July 12, 2024

4101 Calle Abril, San Clemente, CA 92673

Subject: Structural Evaluation of existing structure at 4101 Calle Abril, San Clemente, CA 92673.

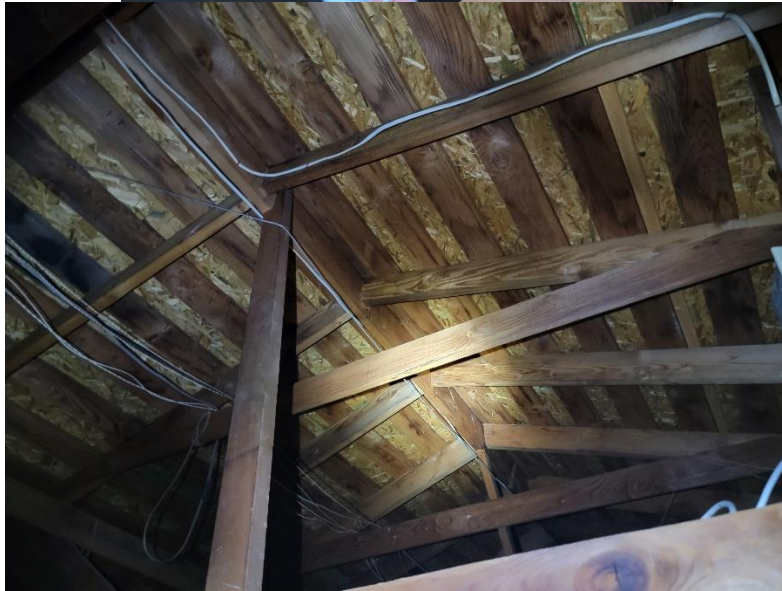
1. The common issue for this era of construction has been observed on the roof framing on rafters' connection to the ridge beams or ridge board, the connection is using only toe nailing and without using rafter hangers. The capacity of this type of connection is questionable and does not comply with the current codes. (Refer to Pictures 9).

Picture 9: View of the roof wood framing from the attic

To address the inadequate roof framing connections where rafters are currently only toenailed to ridge beams or ridge boards without rafter hangers, it is recommended to enhance structural integrity and comply with current building codes. Begin by inspecting all rafter connections and then installing rafter hangers at each connection point. Secure the hangers with appropriate fasteners to ensure a strong and compliant attachment between the rafters and ridge beams or ridge boards. This retrofitting will significantly improve the stability and safety of the roof framing system, aligning it with modern construction standards and enhancing its capacity to withstand structural loads effectively.

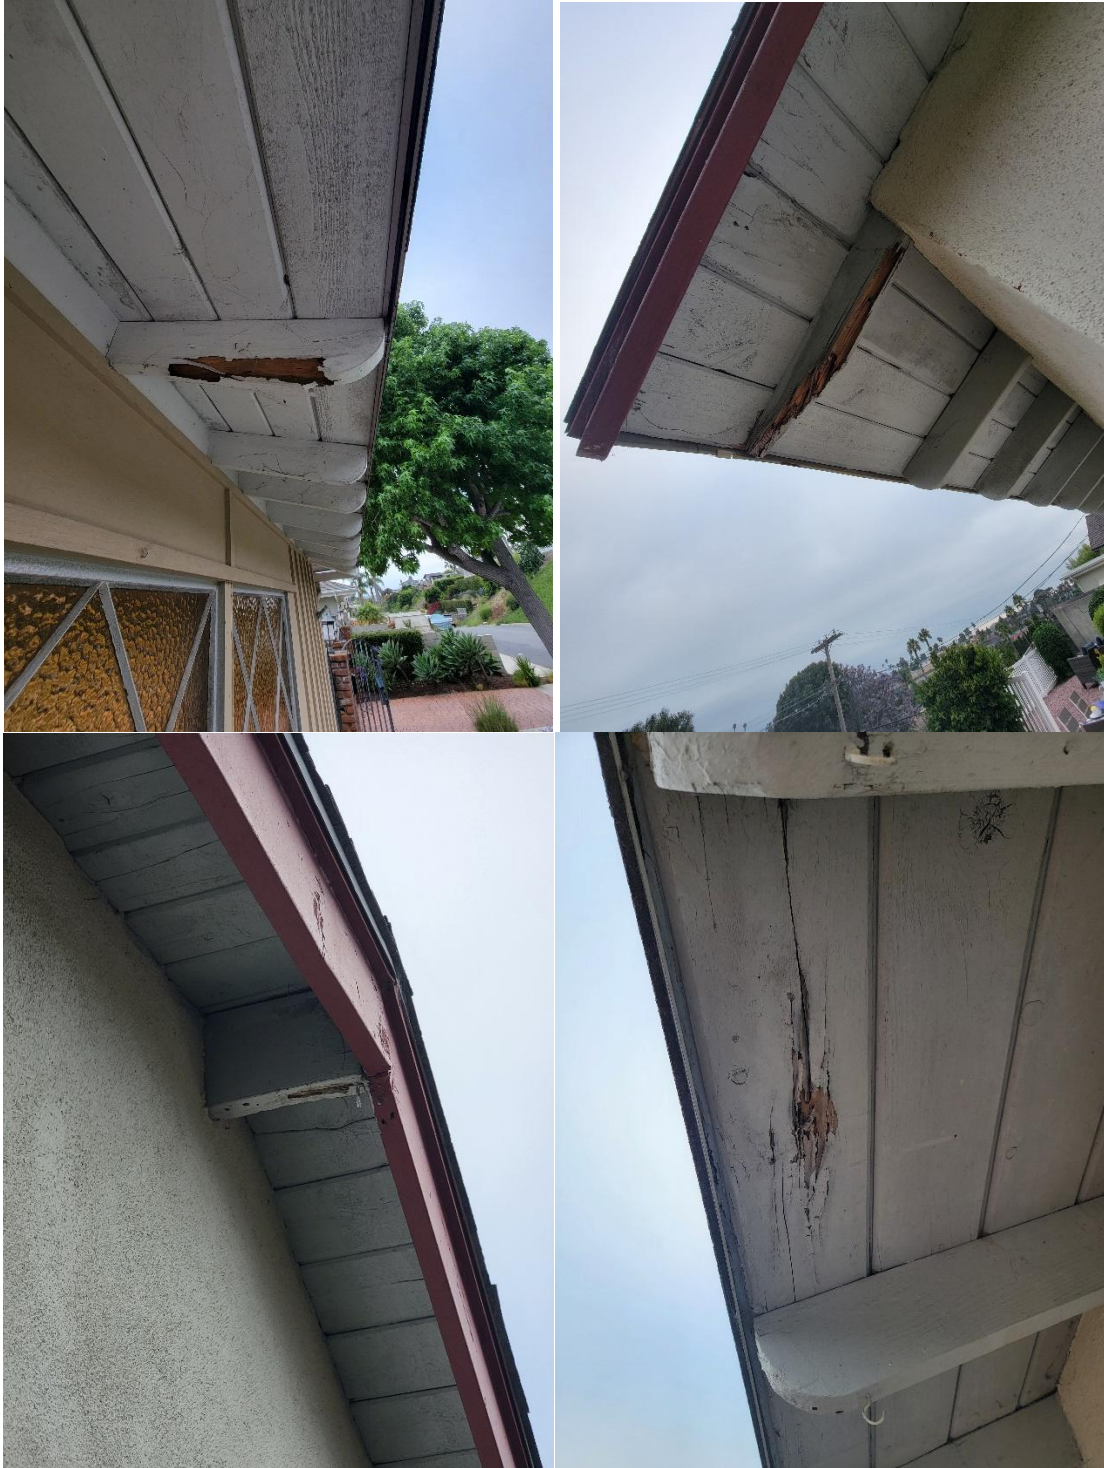
2. Following a detailed inspection of the property, significant instances of dry rot damage have been identified, particularly affecting the roof overhang rafters, overhang soffit, and fascia beam. Action is required to address these issues to prevent further structural deterioration and potential damage to the property. Dry rot is a fungal decay that compromises the structural integrity of wood, leading to weakening and potential failure. Dry rot compromises the strength and stability of structural components, increasing the risk of structural failure, particularly in load-bearing elements such as the roof fascia beam and floor rim joist. (Refer to Picture 10)

Picture 10: Dry rotted wood elements on multiple locations

A full termite inspection is required. Dry rotted framing should be repaired or replaced properly to avoid future damage to the structure.

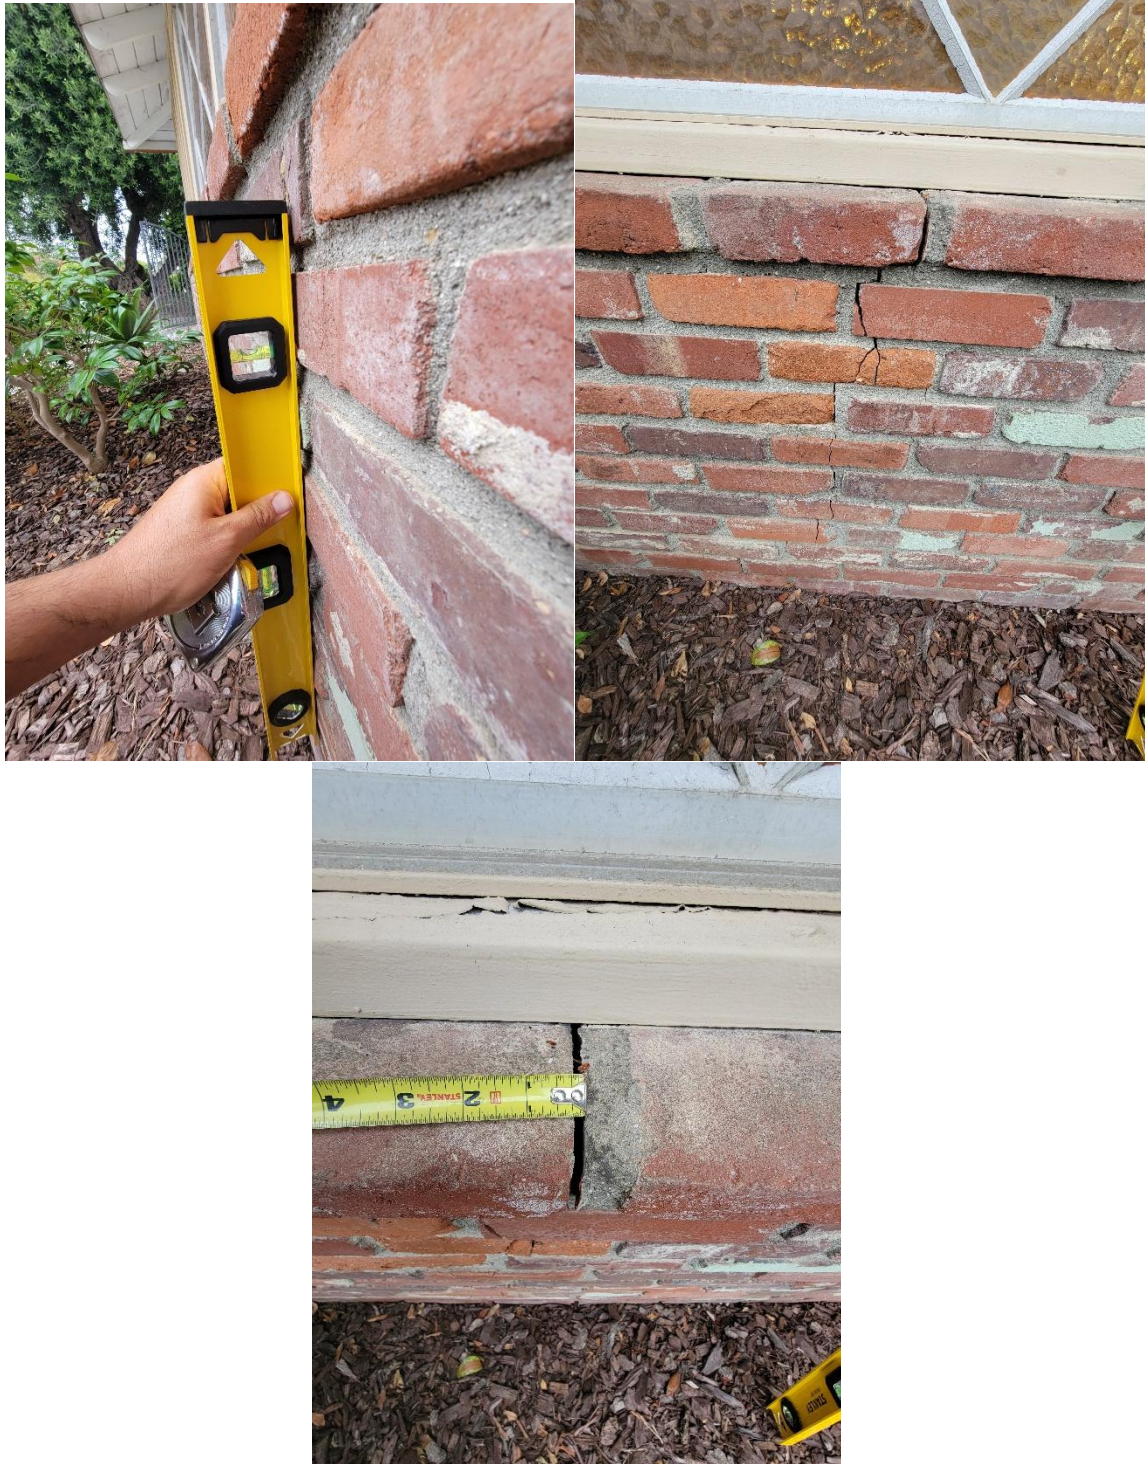
3. Wall bricks on the north side of the garage and house have cracked in multiple locations, likely due to foundation settlement or the expansion and contraction caused by weather and temperature changes. The issue can be fixed after foundation settlement and slab on grade has been addressed. (Refer to Picture

Picture 11: Multiple cracks on brick wall on the garage north wall

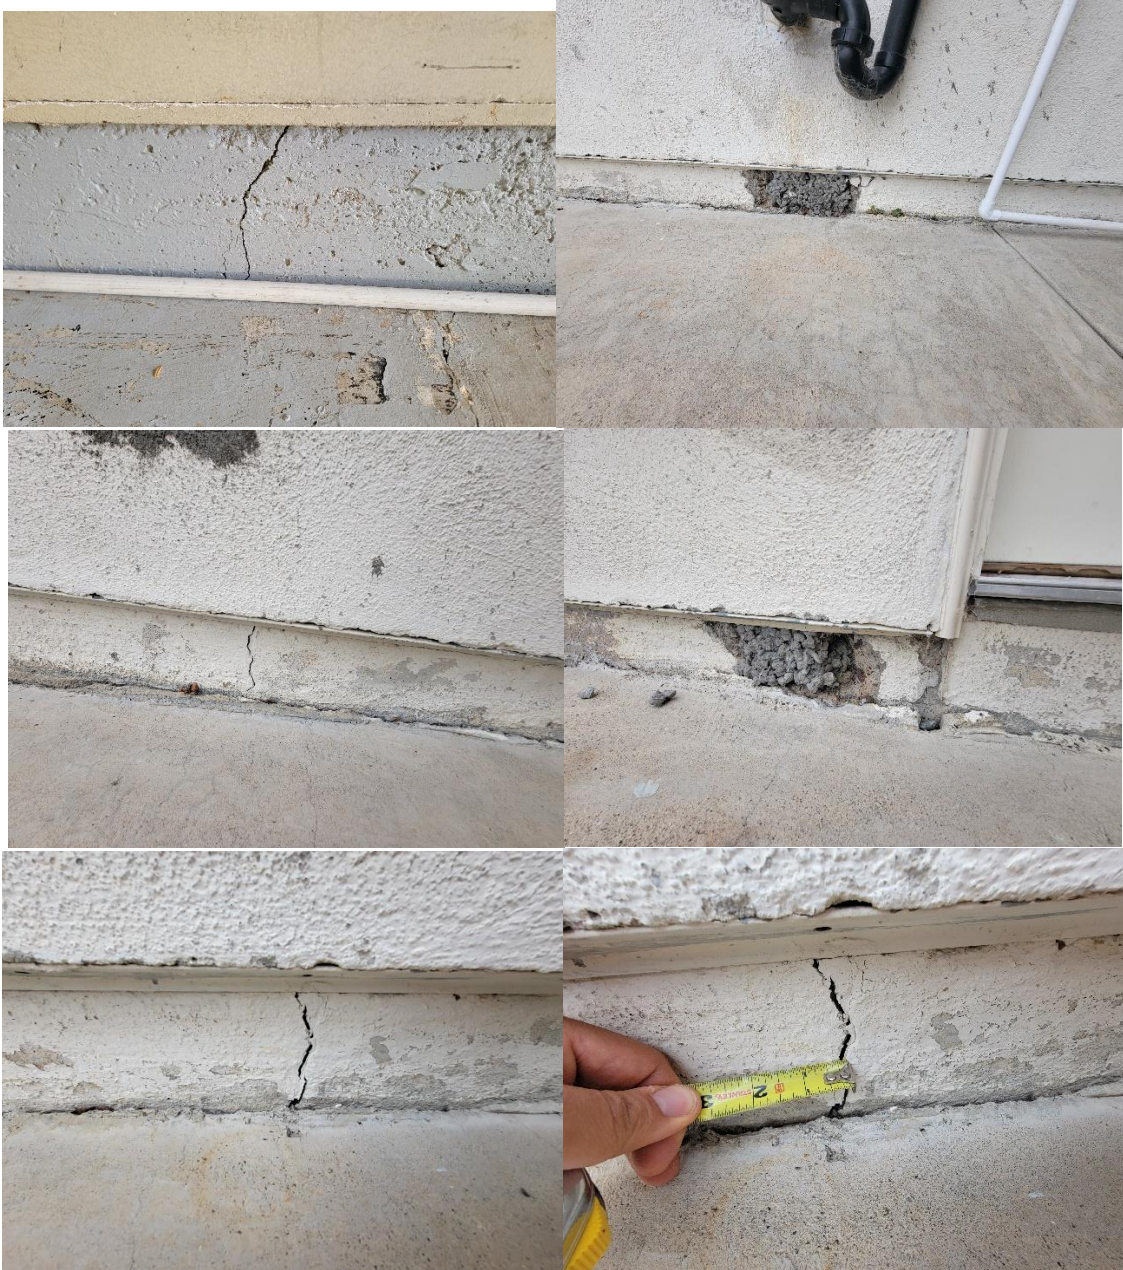
4. Hairline cracks are present on the concrete stem wall in several locations, specifically on the north wall of the garage and along the east side of both the garage and the house. These cracks may indicate underlying issues with the foundation, such as settlement or shrinkage. It is important to monitor these cracks for any signs of widening or progression, as they could potentially compromise the structural integrity of the building. Epoxy injection is required to prevent water intrusion and potential reinforcement corrosion. (Refer to Picture 12)

Picture 12: Hairline cracks on concrete stem wall on multiple instances on the garage north wall, and along east side of the garage and the house

Interior hairline cracks and exterior stucco cracks which are more of visual concern rather than structural, can be repaired with proper methods, products and repair method which should be selected by the contractor.

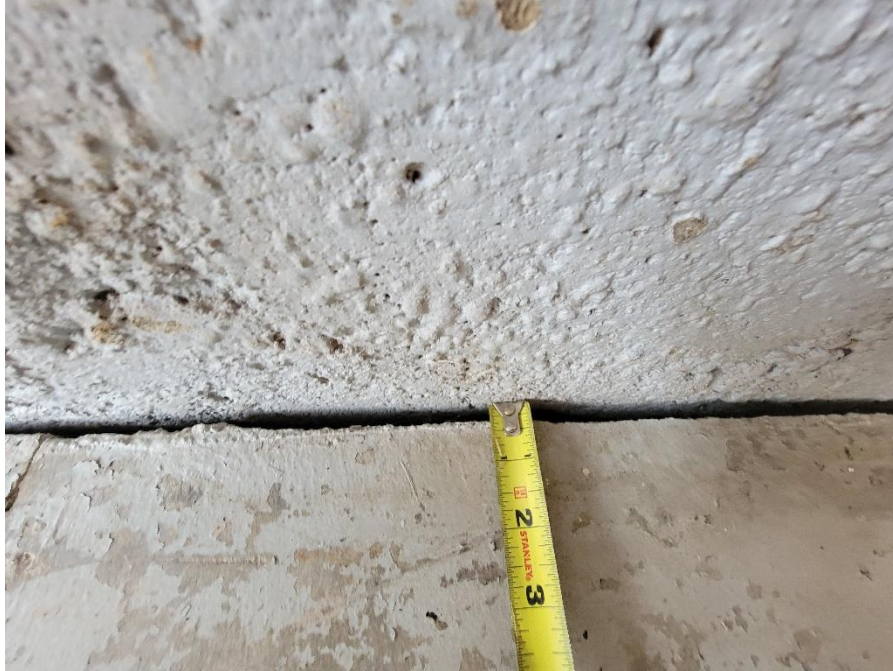
5. A gap of approximately 3/8" has been measured between the garage slab on grade and the concrete stem wall, indicating potential foundation shifting. Additionally, the north wall of the garage is not vertically aligned ("plumb") and exhibits a noticeable tilt of approximately 1.5 degrees towards the south. Further attention and corrective measures are essential to prevent further structural damage and ensure the stability of the garage. (Refer to Pictures 13 and 14)

Picture 13: A gap between the garage slab on grade and the concrete stem wall measured to be approximately 3/8"

- Stabilize the Foundation: Implement foundation stabilization techniques such as underpinning or installing helical piers to prevent further movement.
- Realign the Wall: Correct the tilt of the north wall by carefully jacking it back into place and securing it with additional support if necessary.
- Seal the Gap: Fill the gap between the slab and the concrete stem wall with a suitable sealant to prevent water intrusion and further movement.
- Monitor and Maintain: Regularly monitor the garage and house for any signs of additional movement and perform maintenance as needed to ensure long-term stability.

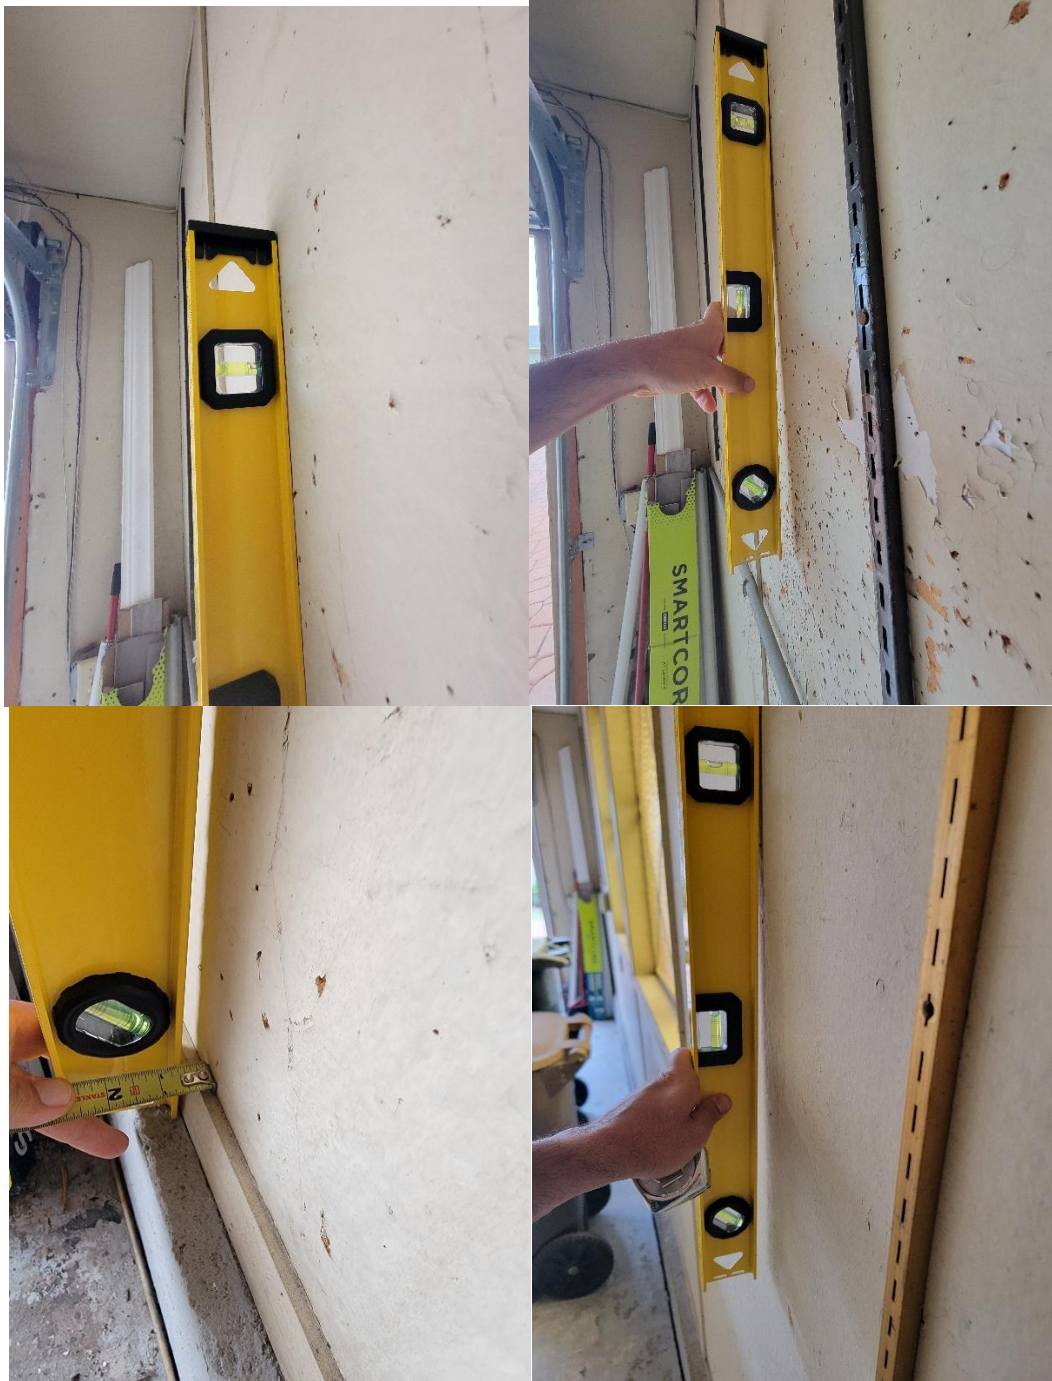
Picture 14: Garage north wall is not vertically aligned “plumb”, exhibiting a tilt of approximately 1.5 degrees towards the south.

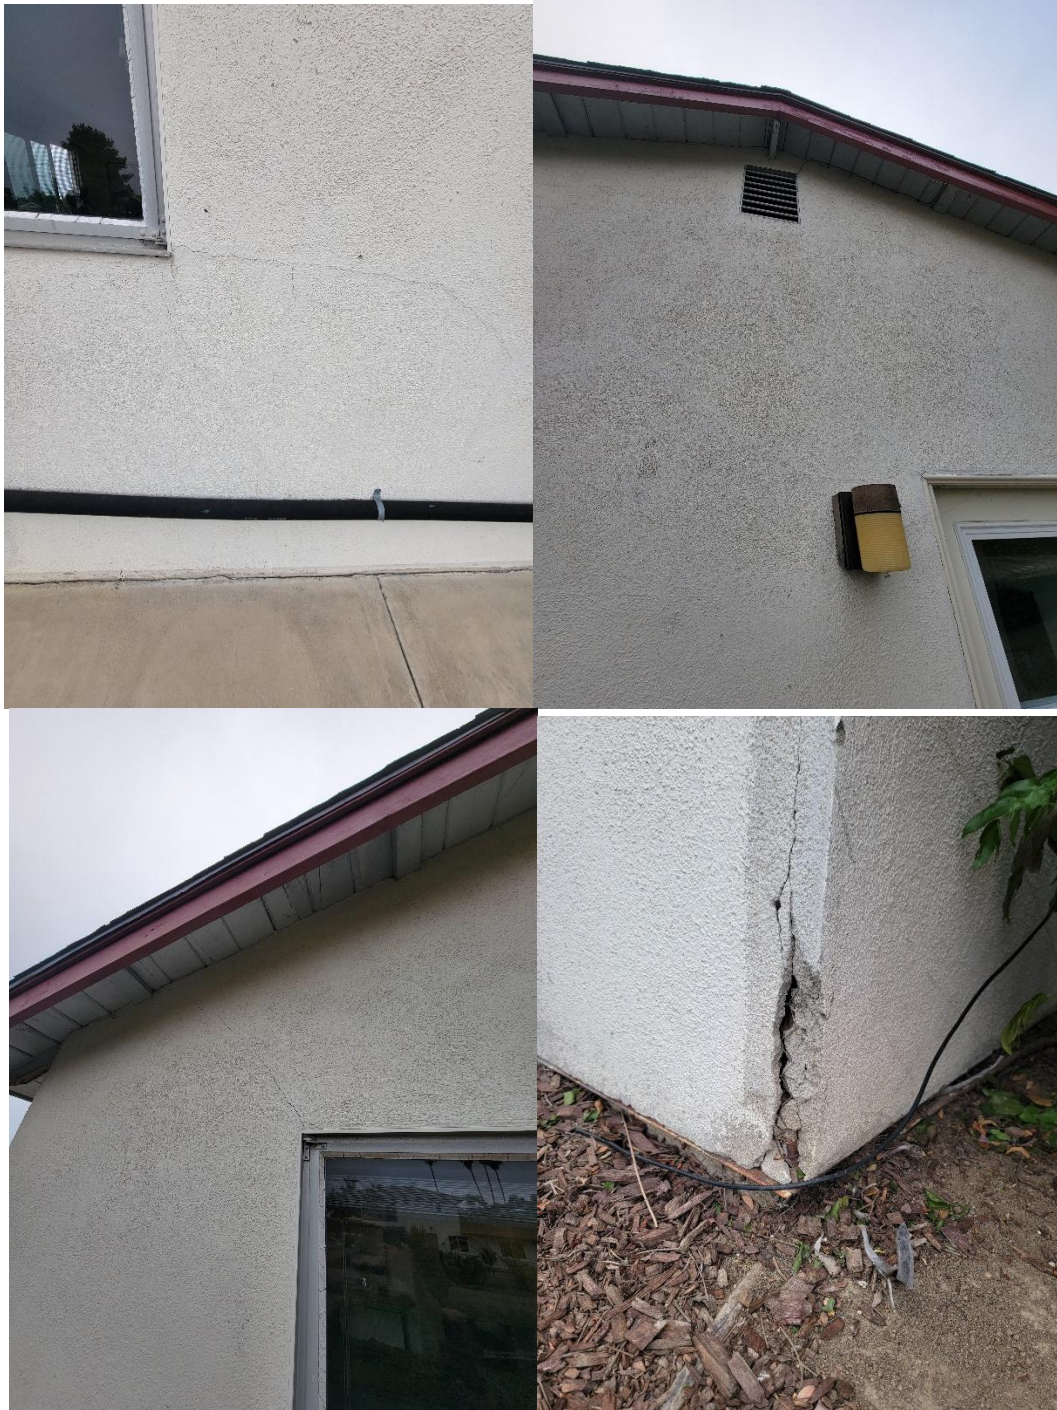
6. Multiple cracks were observed on the exterior stucco on the perimeter wall of the building which mostly measured to be 1/16" wide or smaller. These cracks to be due to shrinkage, expansion, contraction, improper installation or could be due to foundation settlement which are quite common in the residential buildings. (Refer to Picture 15)

Picture 15: Exterior vertical, and diagonal cracks on stucco specially near the openings and corners

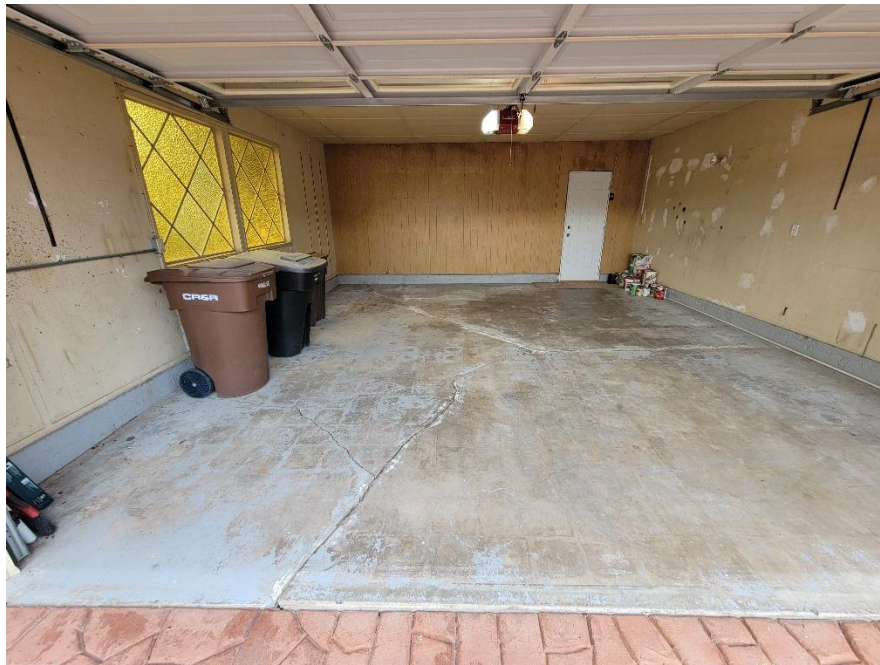
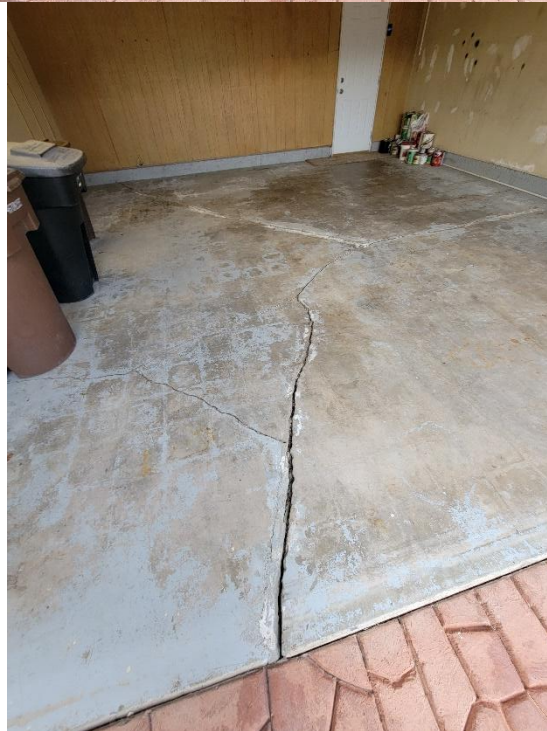
7. The garage concrete slab on grade exhibits several significant cracks, with one particularly notable crack measuring approximately 1" wide. Additionally, there is evidence of settlement, notably on the north segment of the slab, which appears to have settled approximately 1". (Refer to Pictures 16 and 17).

Picture 16: Major structural cracks on the garage concrete slab on grade

- Remove the Damaged Concrete: Cut and remove the cracked and settled portions of the slab.
- Prepare the Area: Clean and prepare the exposed surface for new concrete.
- Install Dowels and Reinforcement: Drill holes into the existing slab and epoxy-inject reinforcing dowels to securely tie the new concrete to the old.
- Pour New Concrete: Pour new concrete to replace the removed sections, ensuring it is properly leveled and aligned with the existing slab.
- Cure and Finish: Allow the new concrete to cure and finish it to match the existing slab.

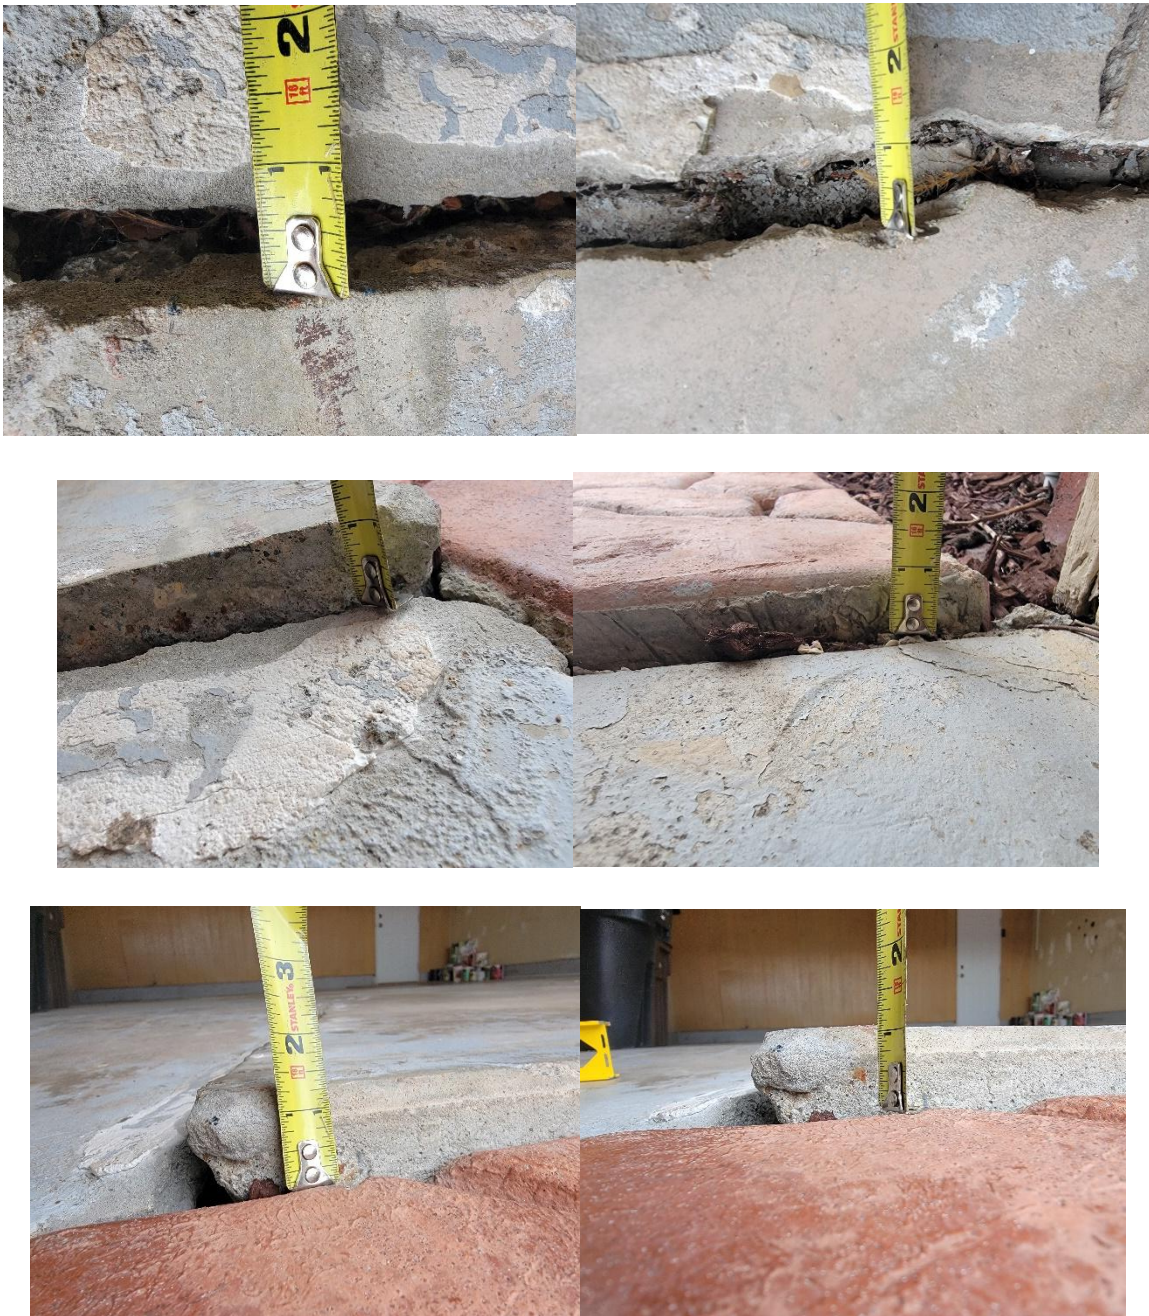
Picture 17: Major structural cracks on the garage concrete slab on grade measured approximately 1" wide and has 1" differential settlement

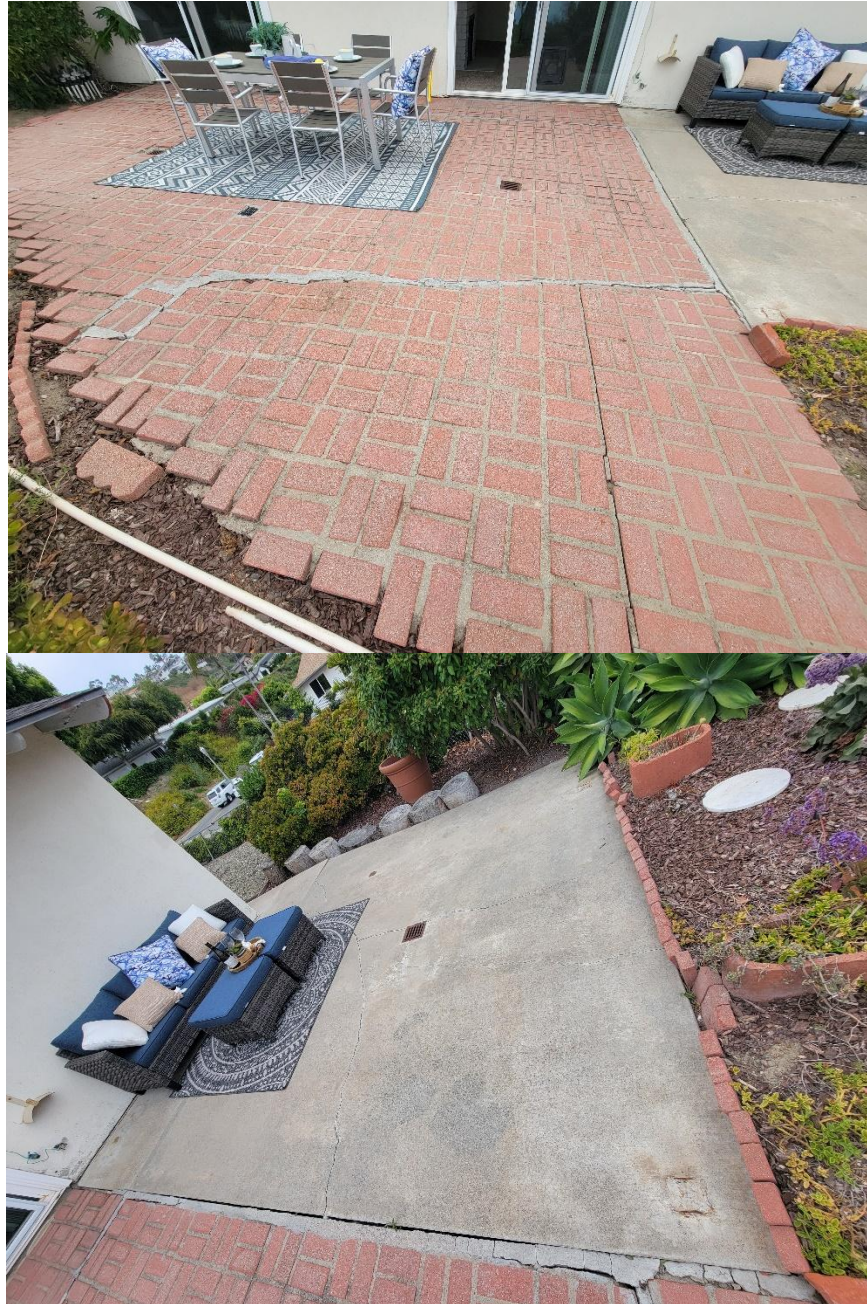
8. Backyard slab on grade has multiple major structural cracks and drastically recessed. The improper soil preparation under the concrete slab is the main reason as appears the soil on this area was fill material and have not been compacted properly and the recess and cracks generated by the soil settlement or soil shifting. (Picture 18 and 19)

Picture 18: Structural cracks on the backyard paving and concrete slab on grade

- Remove Damaged Concrete or paving: Cut out and remove the cracked and recessed sections of the slab.
- Excavate and Prepare the Soil: Excavate the area beneath the slab to remove poorly compacted fill material.
- Compact the Soil Properly: Use compaction equipment to ensure the soil beneath the slab is properly compacted to prevent future settlement.
- Install Reinforcement: Install steel reinforcement mesh or rebar to strengthen the slab.

- Pour New Concrete: Pour new concrete to replace the removed sections, ensuring proper thickness and reinforcement placement.
- Cure and Seal: Allow the new concrete to cure properly and apply a suitable sealer to protect it from moisture and further damage.

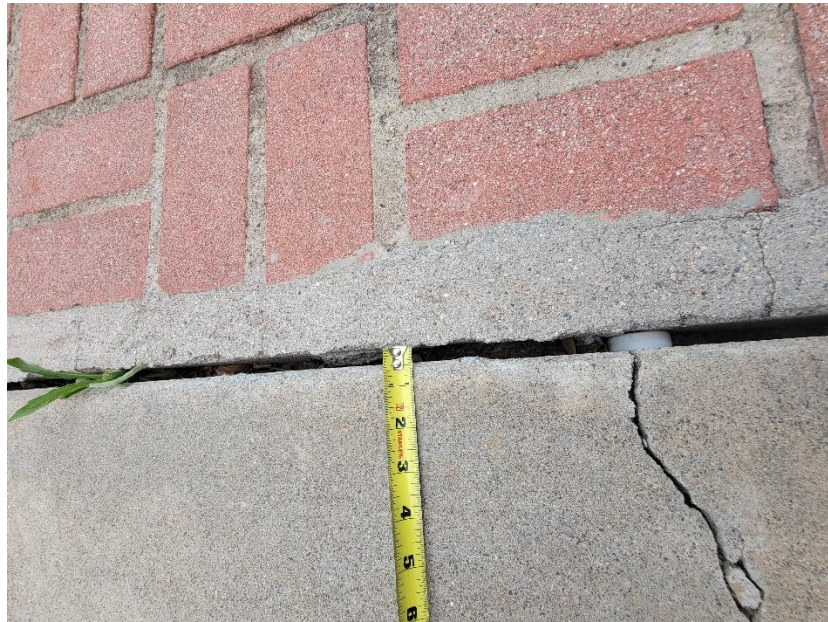
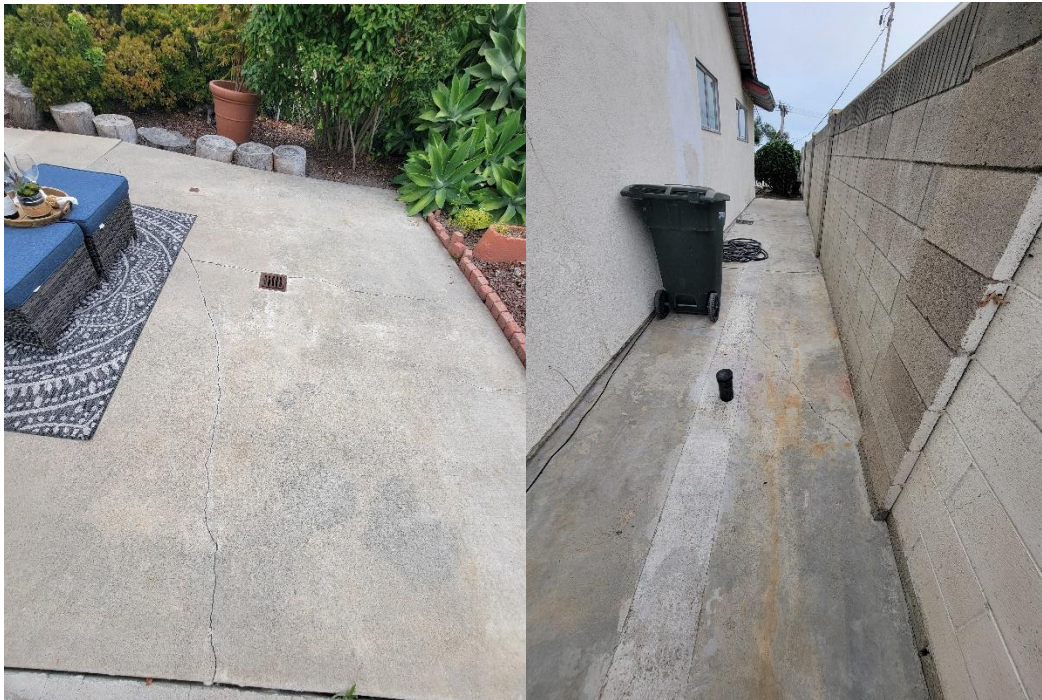
Picture 19: Structural cracks on side yard and backyard paving and concrete slab on grade

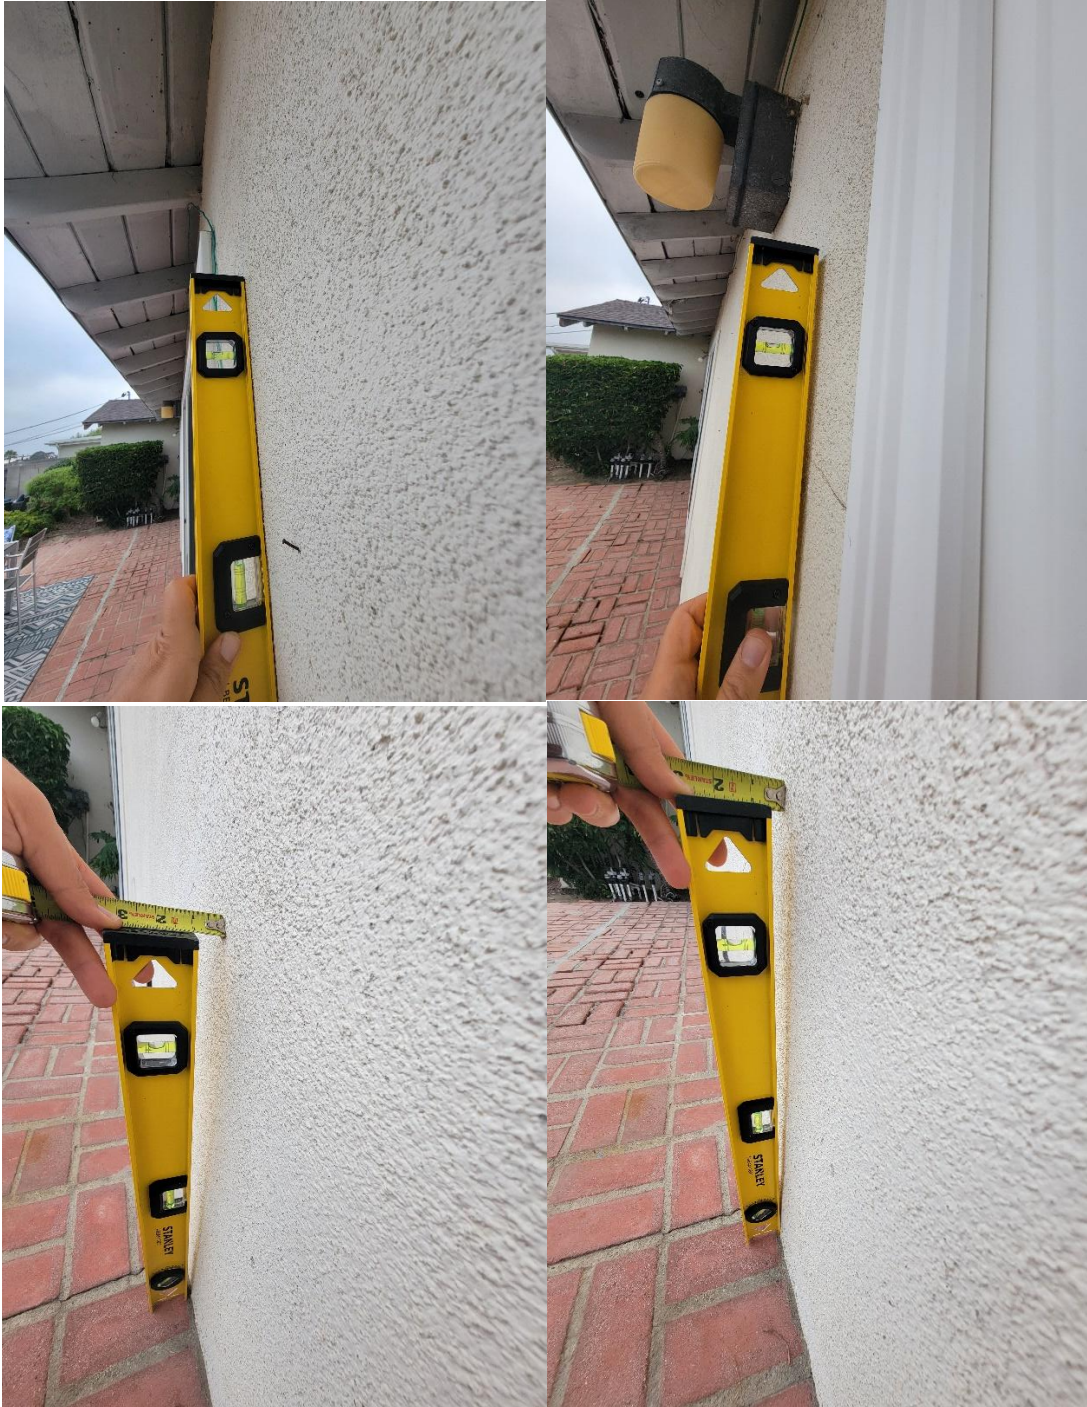
9. The south wall of the house is not vertically aligned "plumb", showing a tilt of approximately 2.5 degrees towards the north. Additionally, the house's slab-on-grade is not flat, with a noticeable slope near the south wall towards the foundation. This unevenness and tilting are likely due to foundation settlement. These issues indicate significant structural movement, which may compromise the integrity of the building. It is crucial to conduct a comprehensive inspection after carper removal to assess the extent of the foundation problems and implement necessary corrective actions to ensure the stability and safety of the house. (Pictures 20 through 23)

Picture 20: House south wall is not vertically aligned “plumb”, exhibiting a tilt of approximately 2.5 degrees towards the north.

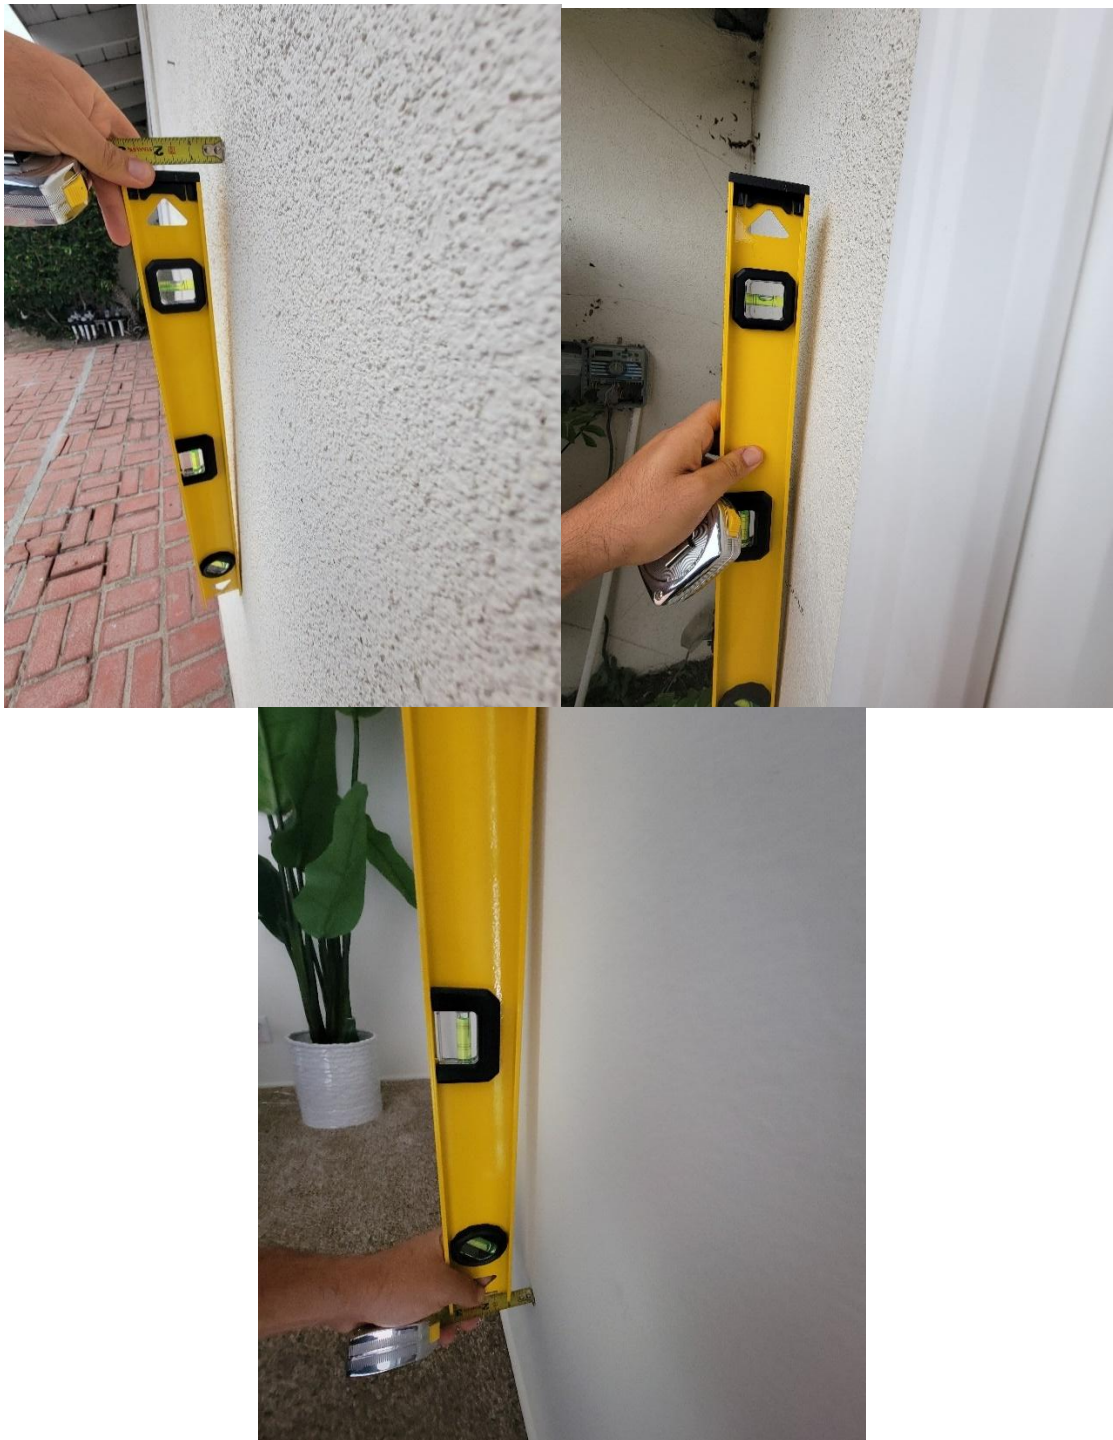
Picture 21: House south wall is not vertically aligned “plumb”, exhibiting a tilt of approximately 2.5 degrees towards the north.

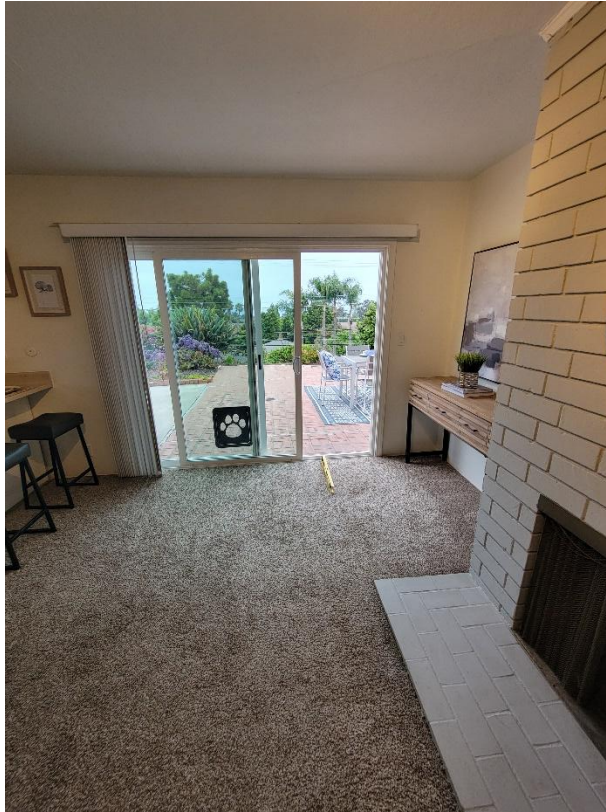
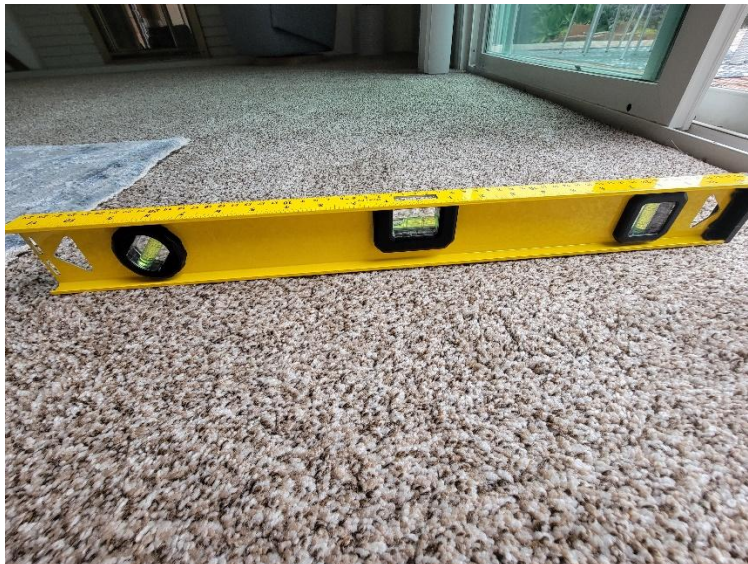
Picture 22: House slab on grade is not flat sloping near south wall towards the foundation potentially due to foundation settlement

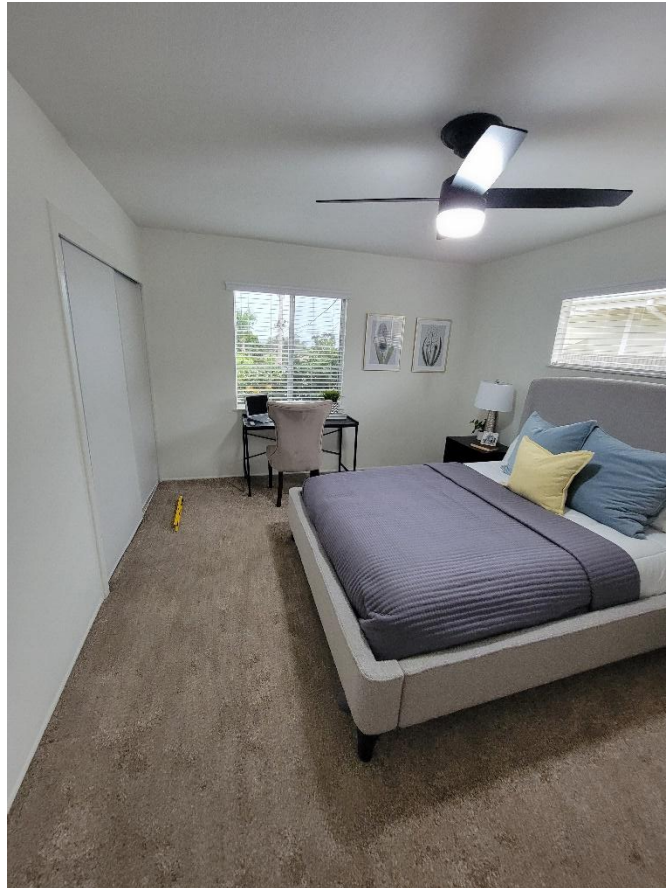
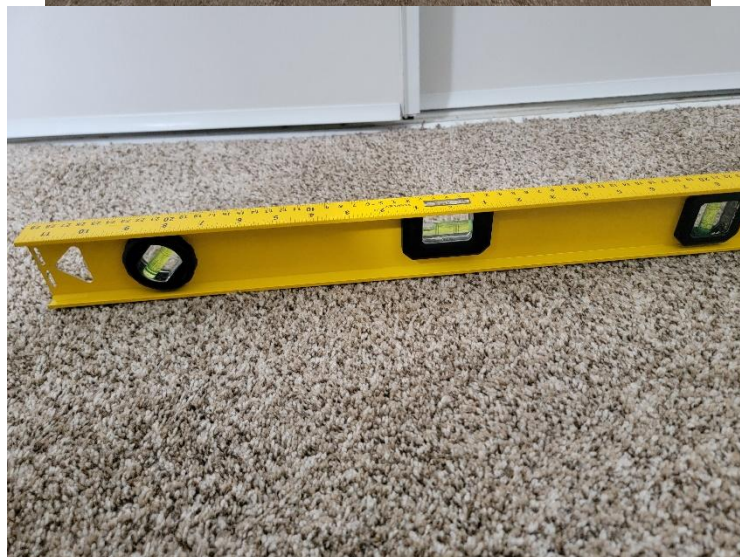
Picture 23: House slab on grade is not flat sloping near south wall towards the foundation potentially due to foundation settlement

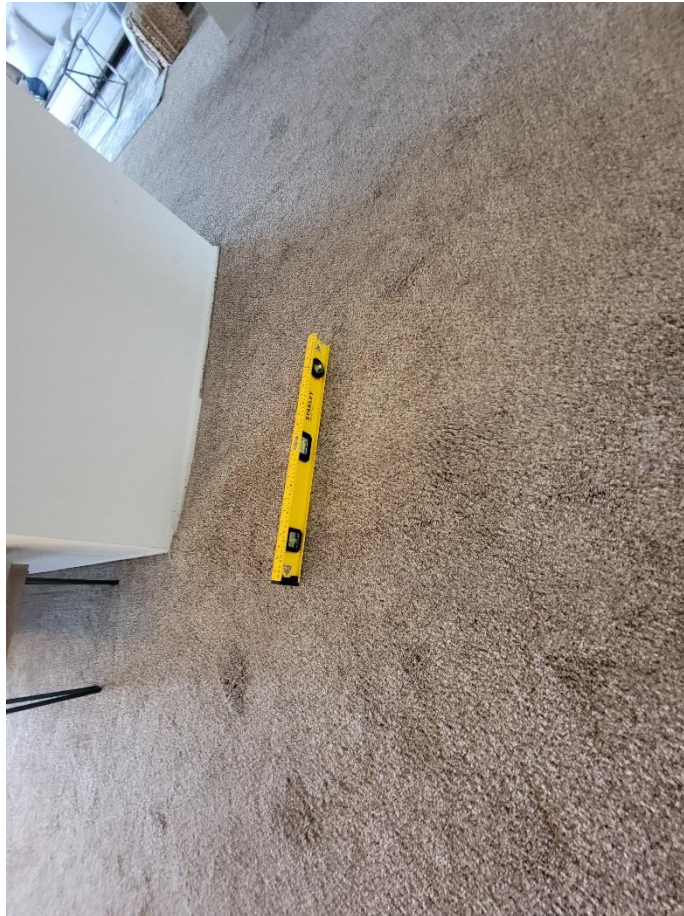
10. The concrete slab-on-grade of the house is not horizontally aligned or flat in numerous locations. This unevenness is potentially due to cracks in the slab, settlement issues, or slab lifting caused by expansive soil conditions. To accurately assess the extent of these problems, the existing carpet should be removed to allow for a thorough inspection of the underlying slab. Identifying and addressing these issues is essential for maintaining the structural integrity and safety of the house. (Refer to Picture 24)

Picture 24: House concrete slab on grade is not horizontally aligned or flat on many locations potentially due to slab on grade cracks, settlement, or slab lift due to potential expansive soil
