July 18, 2024

4653 & 4659 3<sup>rd</sup> street, La Mesa, CA 91941

Subject: Senate Bill #721 & 326- Structural Evaluation of existing exterior stairs at 4653 & 4659 3<sup>rd</sup> street, La Mesa, CA 91941

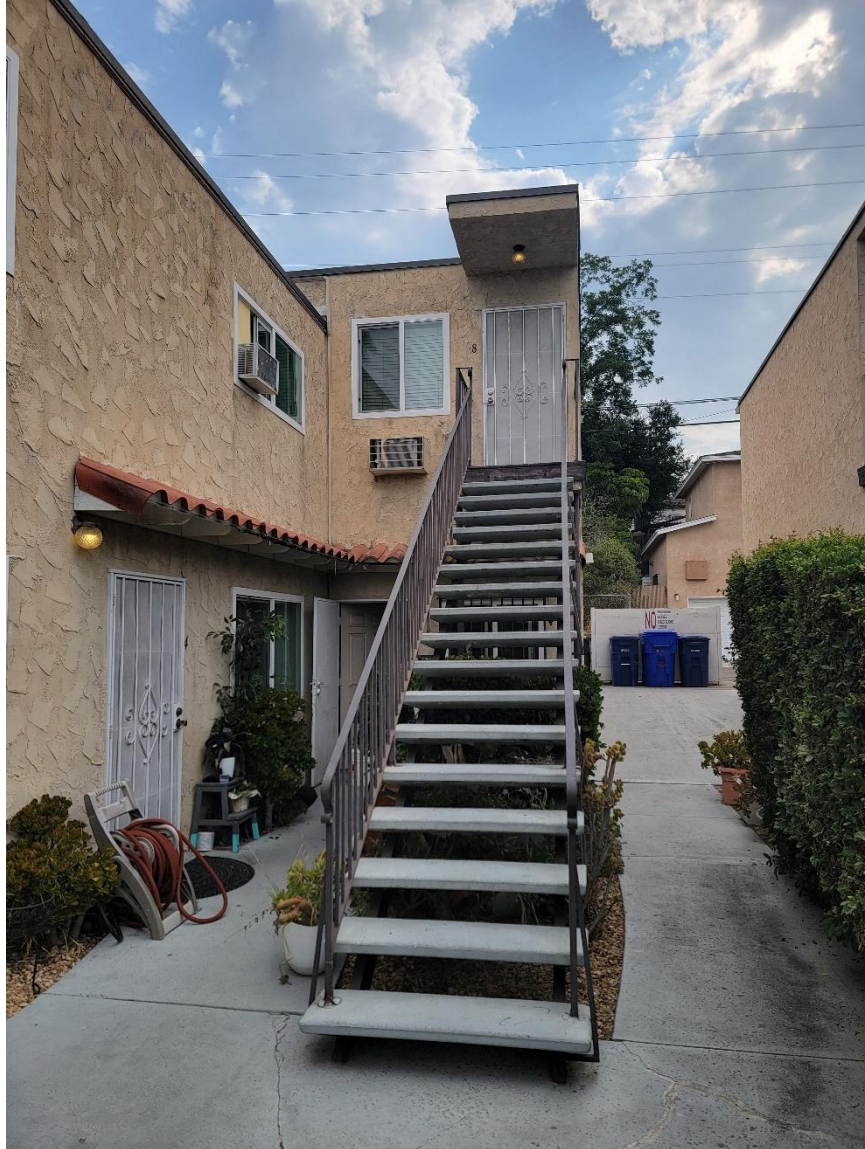
Picture 2: North stair at 4659 3<sup>rd</sup> street.

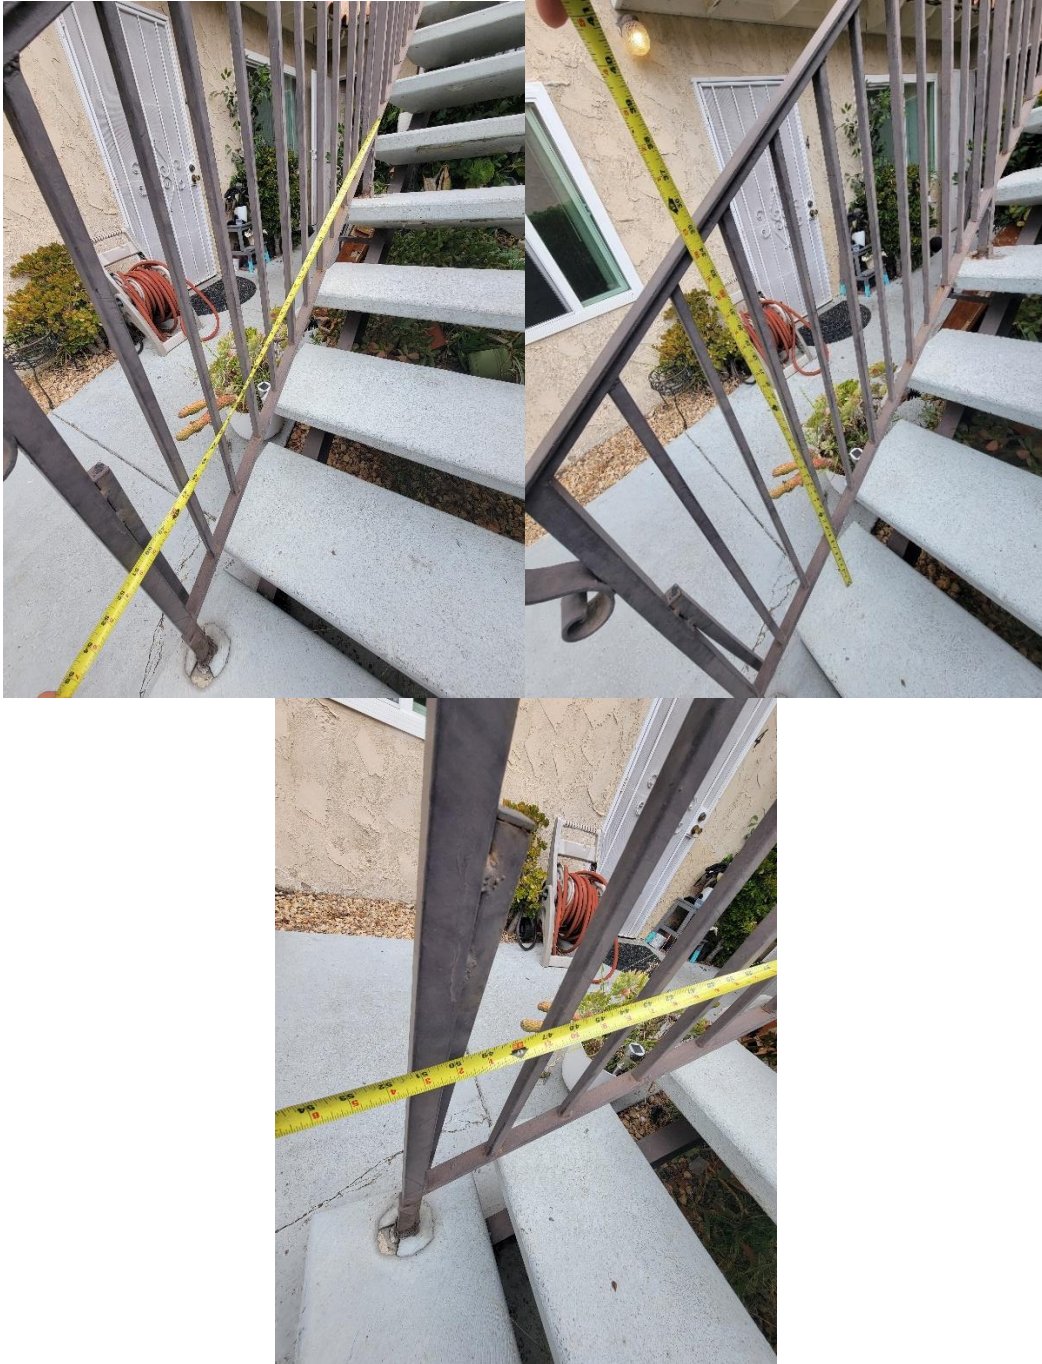
- 1- All the stair railings are made of steel railing, they are 35" high and use different post spacing about 4 feet and more up to 5 feet 6 inches using different type of non-standard anchorage to concrete treads. The landing railing is 42" high, post spacing varies from 4 feet 5 inches post spacing up to 5 feet 6 inches, different non-standard railing post anchorage have been used and on many of them, the landing concrete topping is cracked near the anchorage. The landing or walkway top rails connect to the stucco wall. The majority of railing post anchorage capacity to resist current code level loads are questionable. Per current California

Picture 3: The stair railing is 35" high, post spacing varies with approximately 4 feet 2 inches post spacing on this picture.

To replace the proper guard railing system to comply with the current code, the existing stair and landing/walkway condition shall be verified by reviewing the record drawings when available or removing the topping concrete to measure the concrete thickness and locate the buried framing below and evaluating any possible hidden wood deterioration on joist/beams or corrosion on steel framing under the concrete topping. Note that removing, replacing, and repairing any possible dry rotted wood or corroded steel framing might be required. When the thickness of concrete topping is not adequate for future post anchorage, other methods of anchorage such as anchor to wood framing/ blocking or steel framing below should be investigated. When as-built information of framing is available, the new railing configuration and anchorage design comply with current codes that should be conducted and designed by a professional engineer.

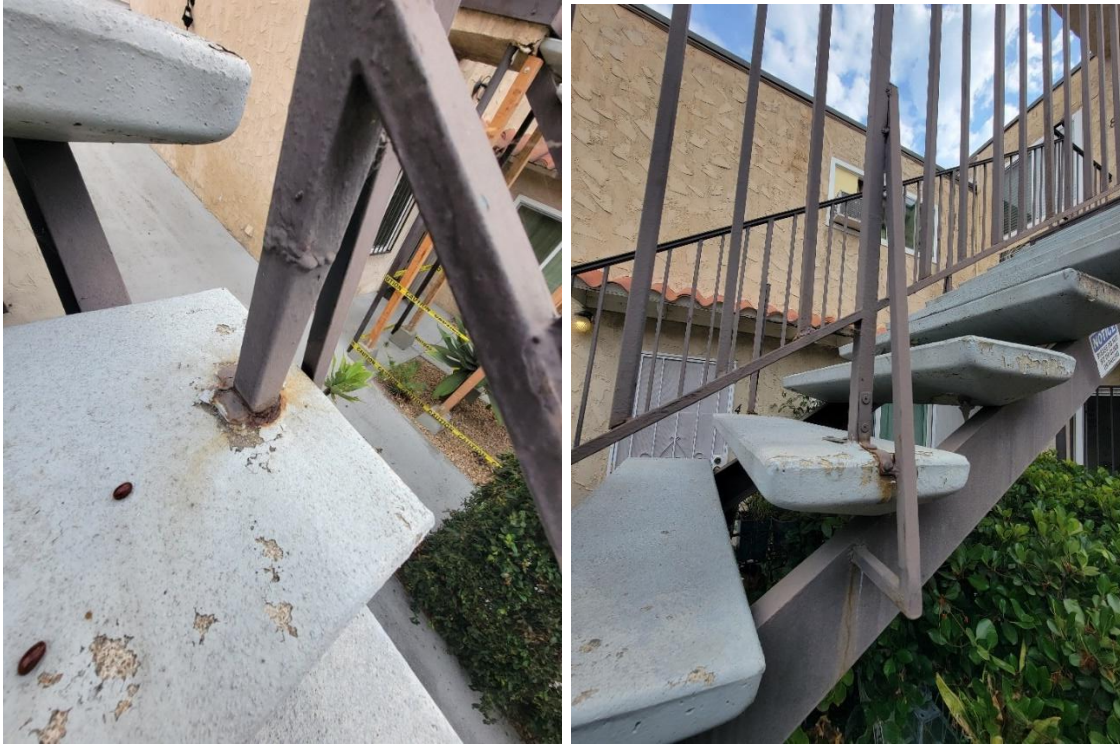
Picture 4: Different non-standard post anchorage to the concrete treads and steel stringer

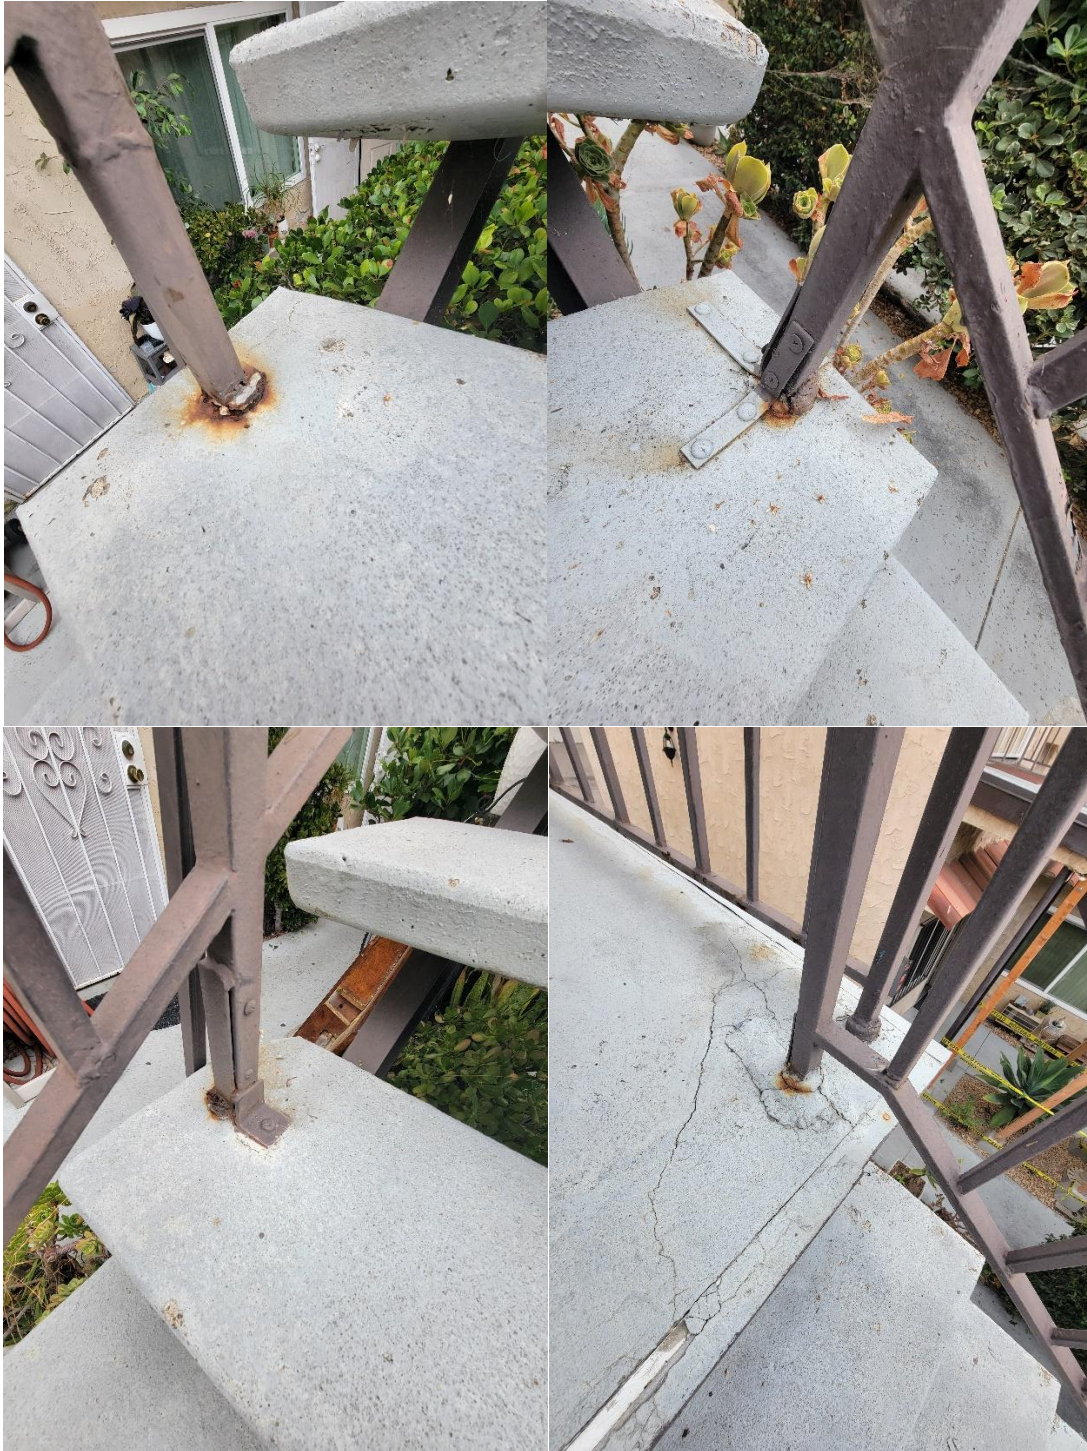
Picture 5: Non-standard post anchorage to the concrete treads or cracked concrete topping on landing.

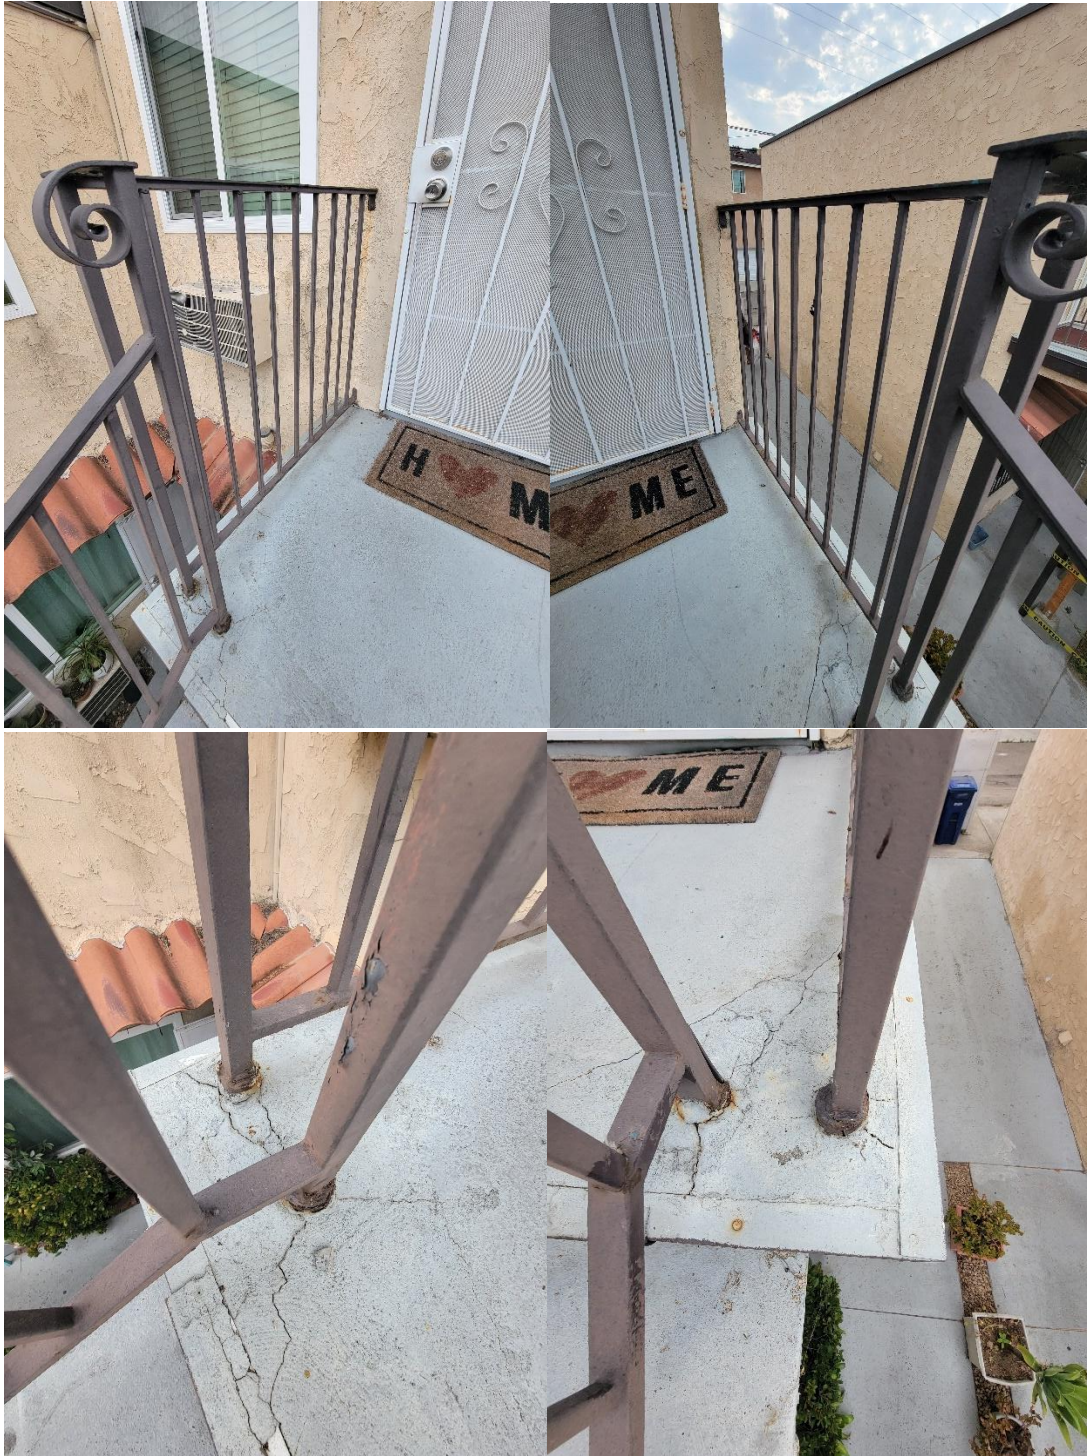
Picture 6: Non-standard post anchorage to the cracked concrete topping on landing.

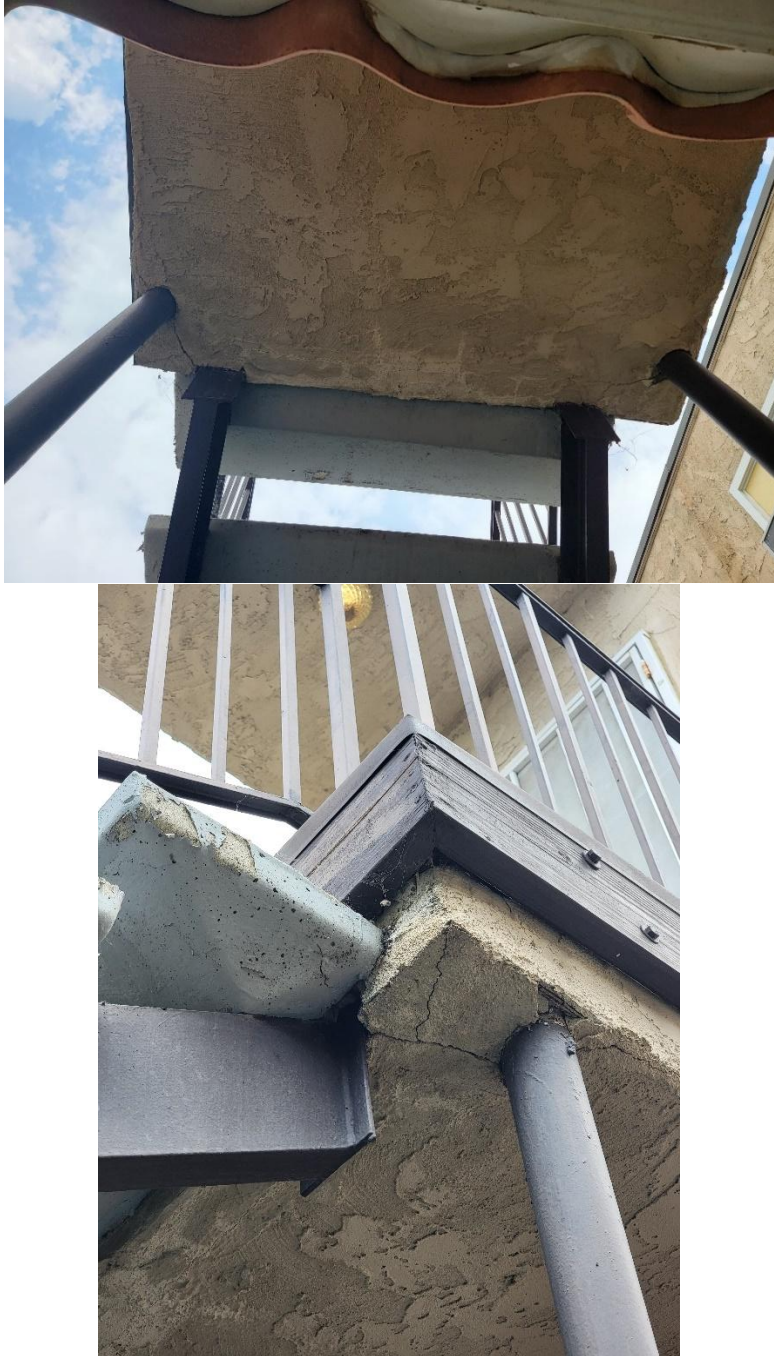
- 2- All of stair steel stringer connection to the landing structure are questionable as the stucco near the connections are cracked. The connections required to be exposed for further evaluation. Especially on the south stair at 4653 3<sup>rd</sup> street, the stair is settled on the west side approximately 1" relative to the east side of it. (see pictures 7, 16, 25, 30, and 32).

Picture 7: View of stair steel stringer connection to the landing's framing which is not exposed to be verified. Cracked stucco around the steel posts.

All of stair steel stringer connection to the landing structure required to be exposed for further evaluation.

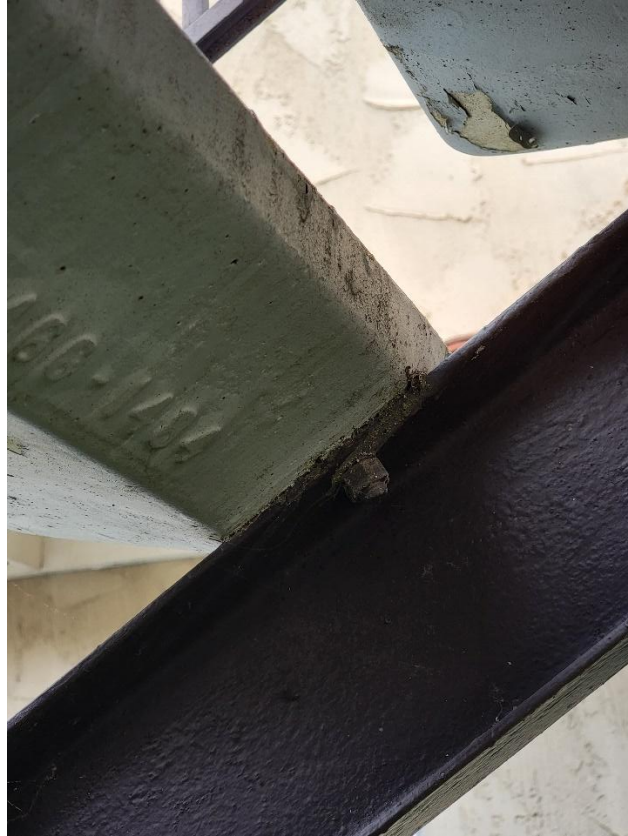
Picture 8: Typical concrete treads bolted connection to the stair steel stringer

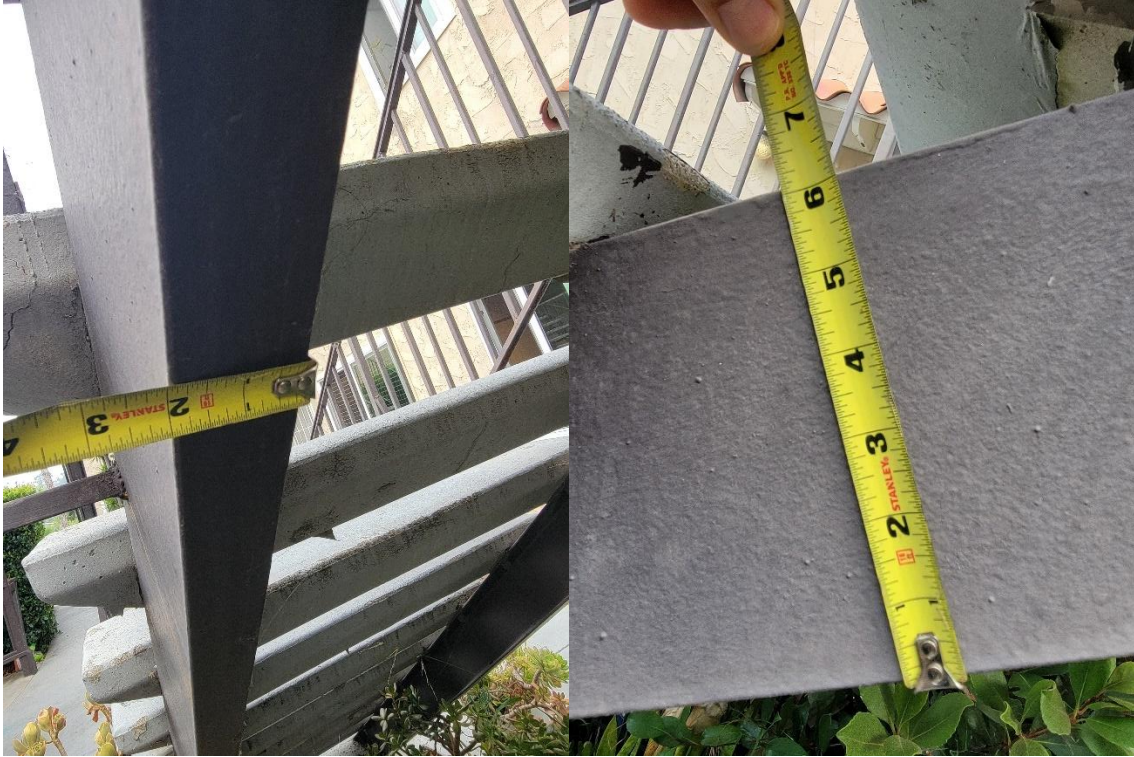
Picture 9: Steel stringers are channel measured 6" deep and 2" flange width.

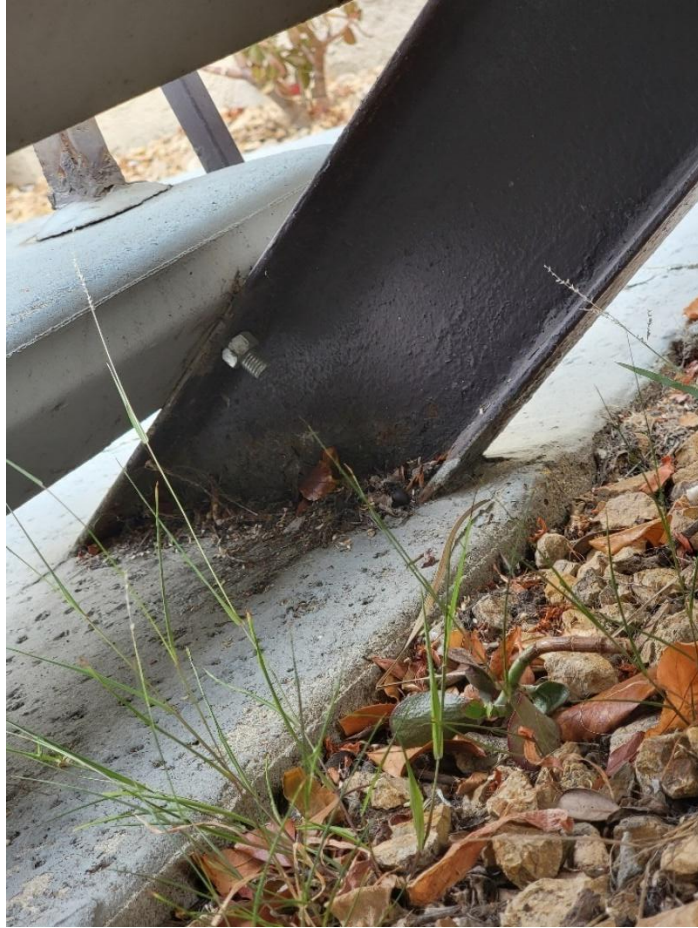
Picture 10: Typical steel stringer connection at the slab on grade

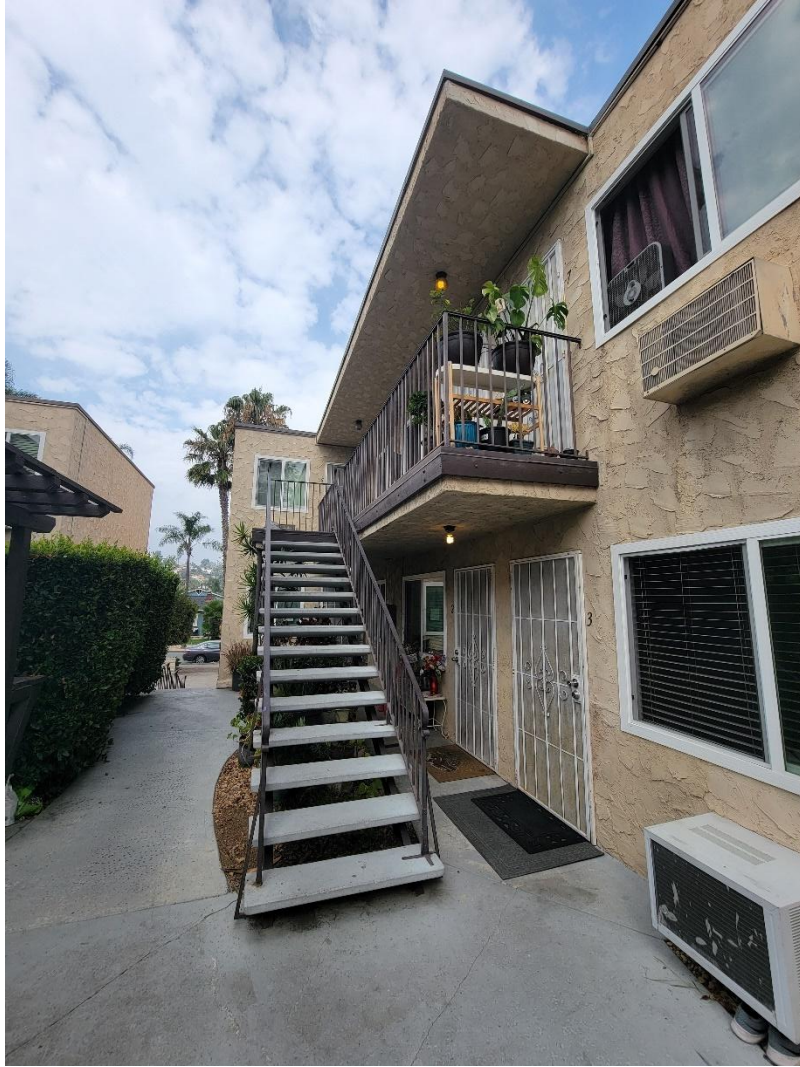
- 1- On the south stair at 4659 3<sup>rd</sup> street, the stair railings on both sides and landing and walkway railings are wobbly and unsafe. The post anchorages are non-standard and some of them extensively corroded, or the landing concrete topping is cracked near the post anchorage, and some of the base anchorage is inadequate and loose. (Refer to Pictures 11 through 14, and 16 through 18).

Picture 11: South stair at 4659 3<sup>rd</sup> street which all the stair railing and landing railings are wobbly and unsafe.

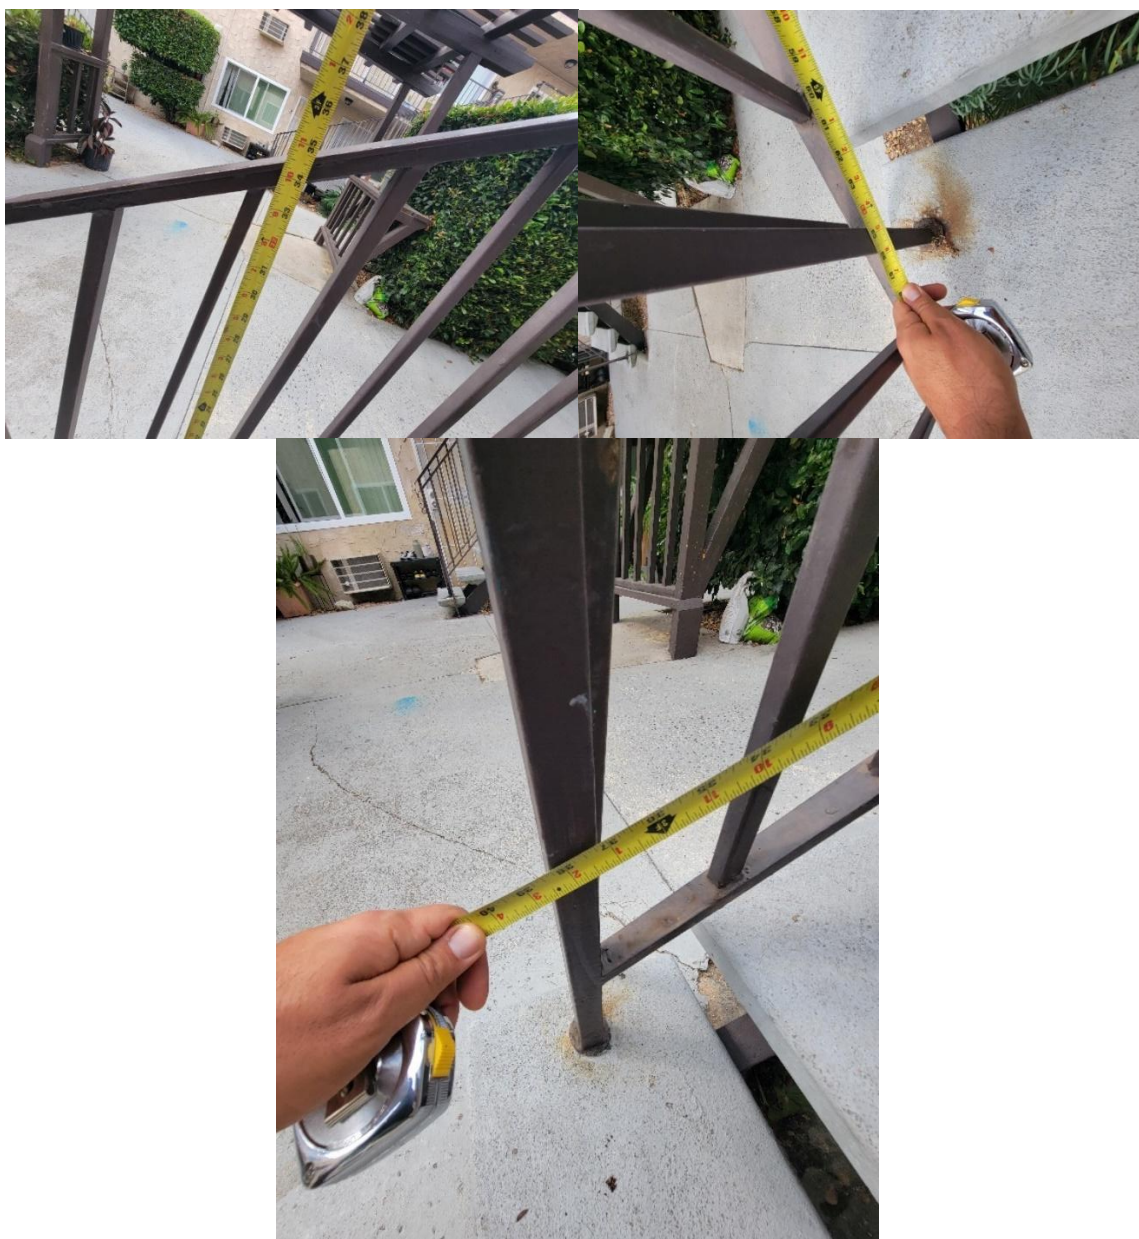
Picture 12: The stair railing is 35" high, post spacing varies with approximately 3 feet and 2 inches and 5 feet 5 inches post spacing on these pictures.

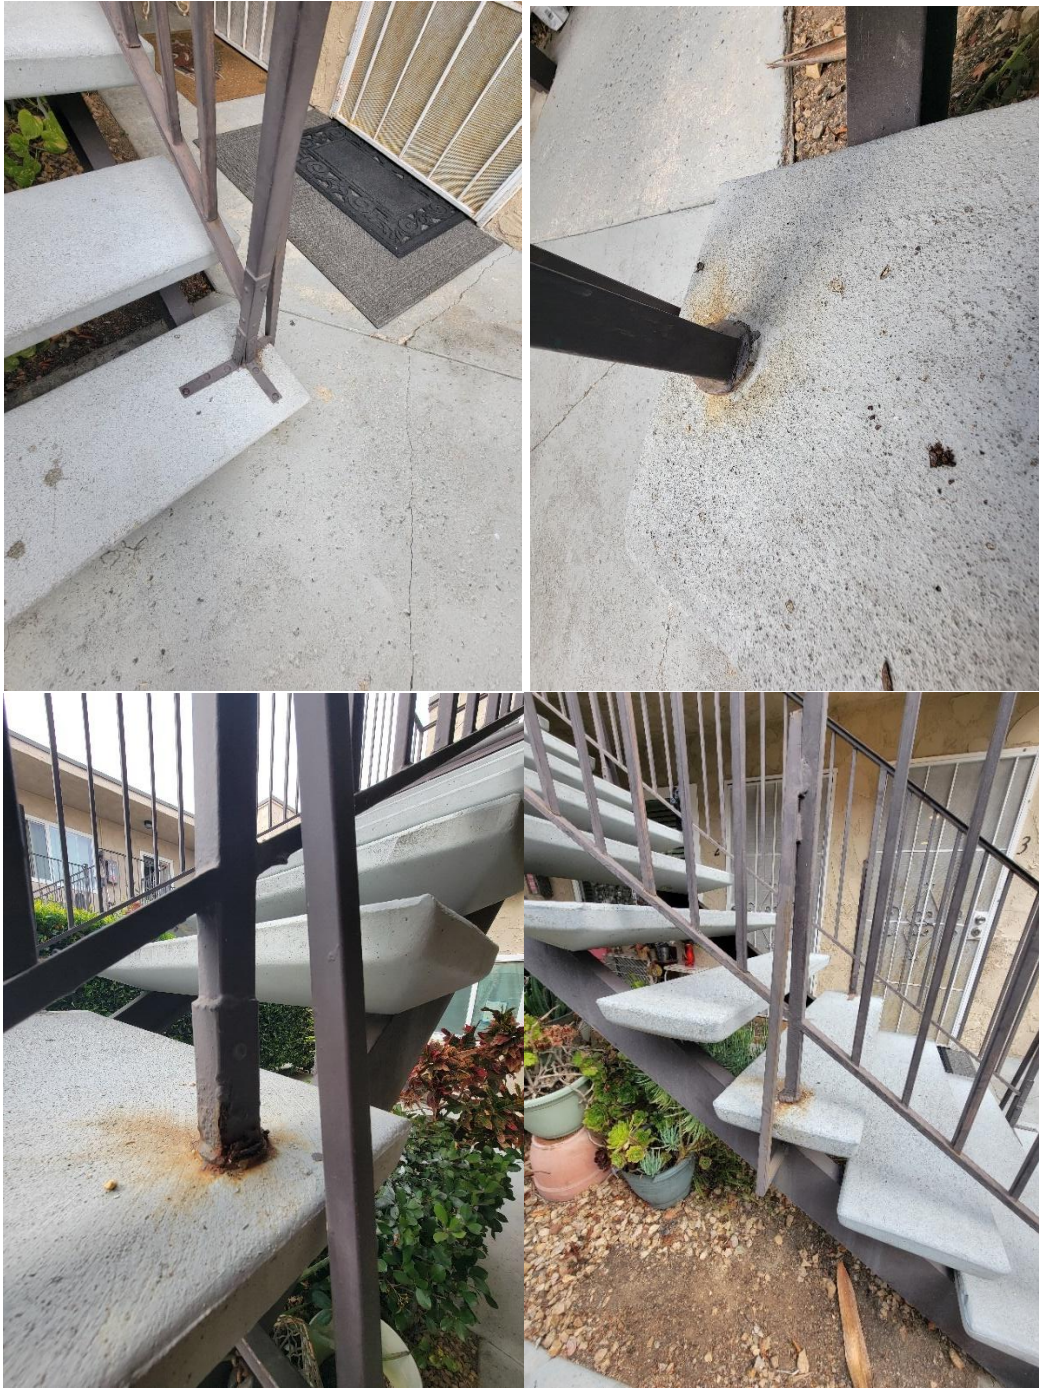
Picture 13: Different non-standard post anchorage to the concrete treads and steel stringer

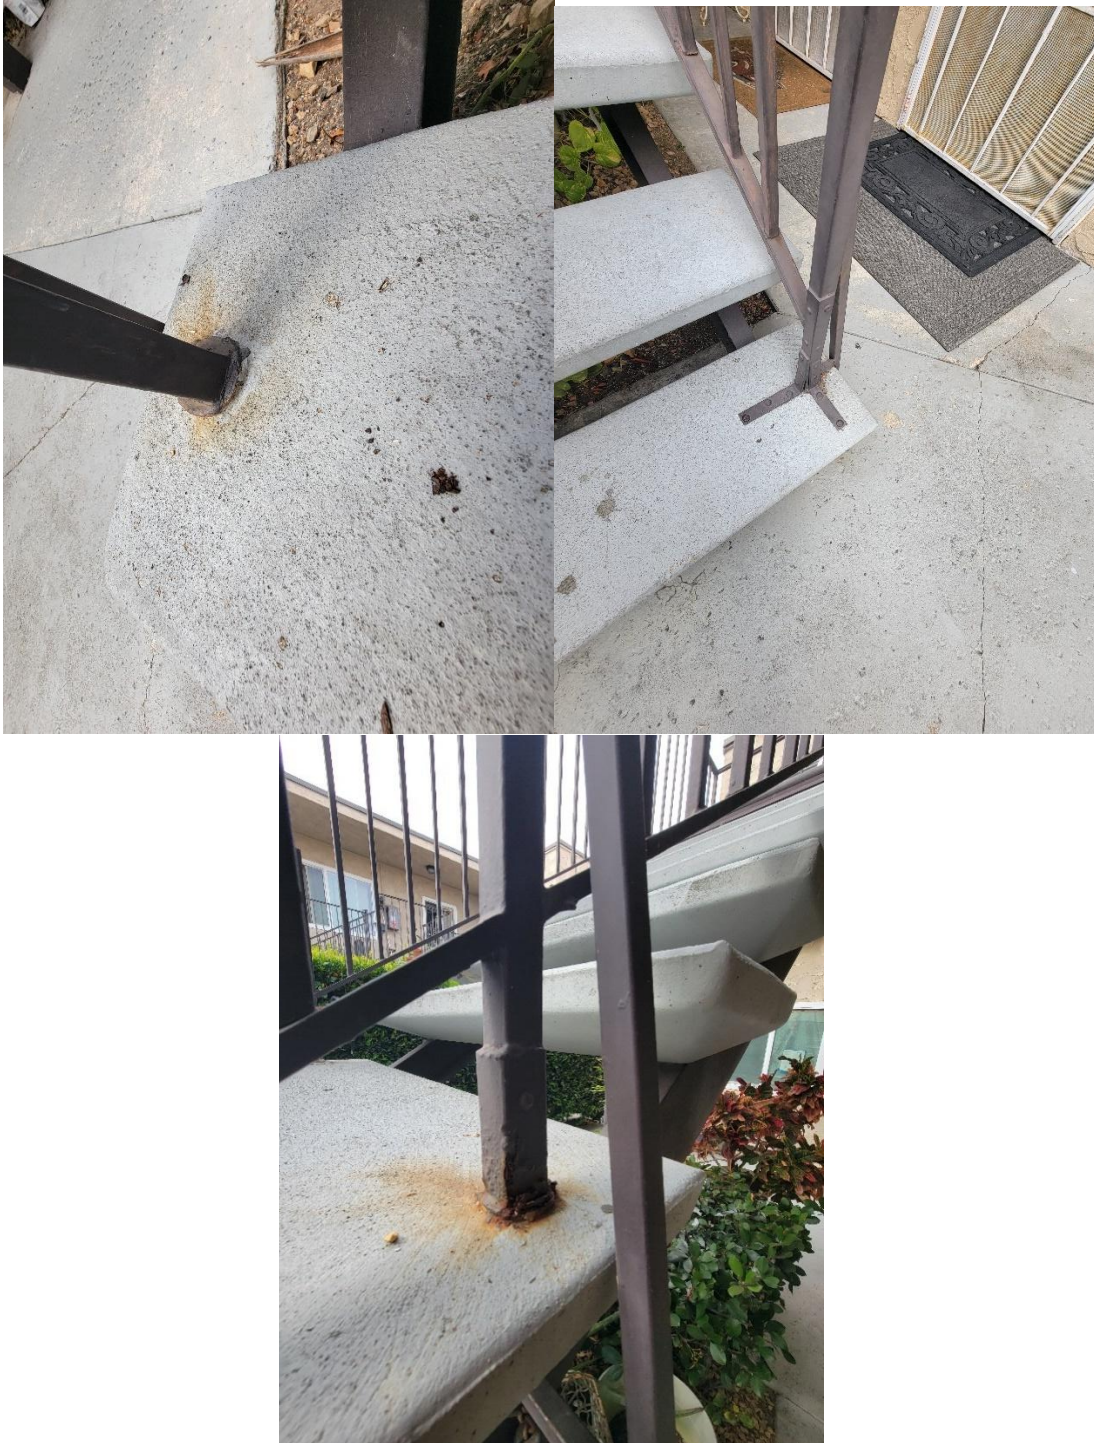
Picture 14: Different non-standard post anchorage to the concrete treads and steel stringer

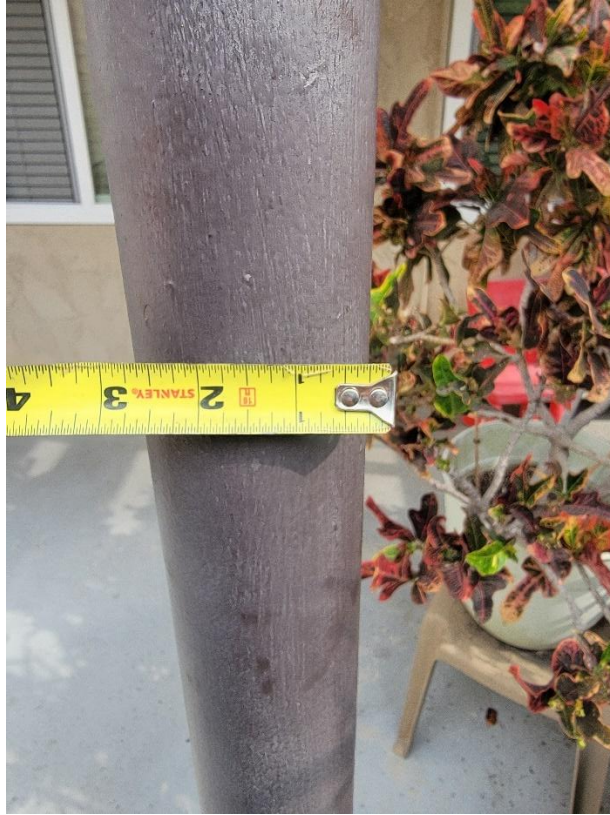
Picture 15: Typical steel tube post measured 3" outer diameter.

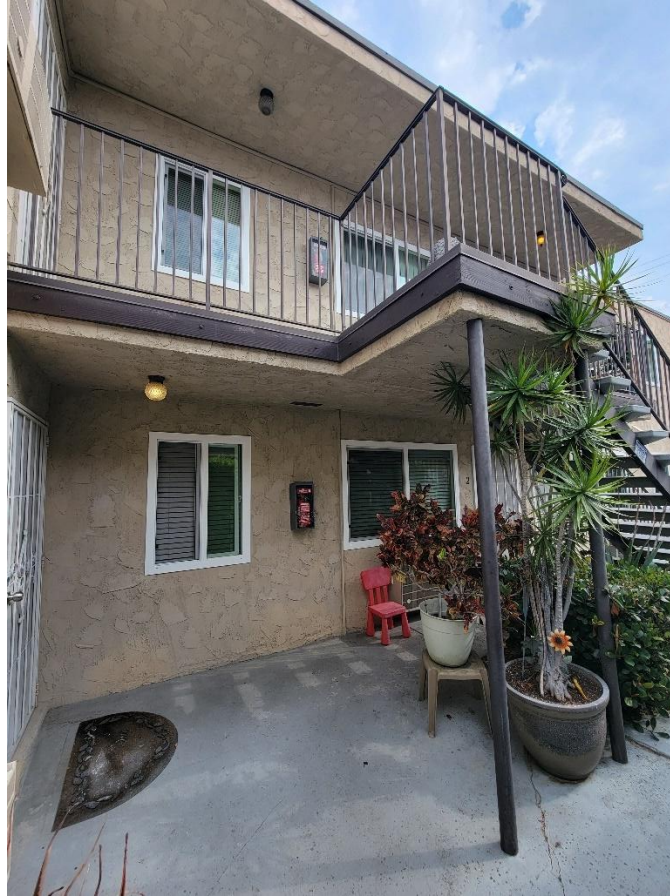
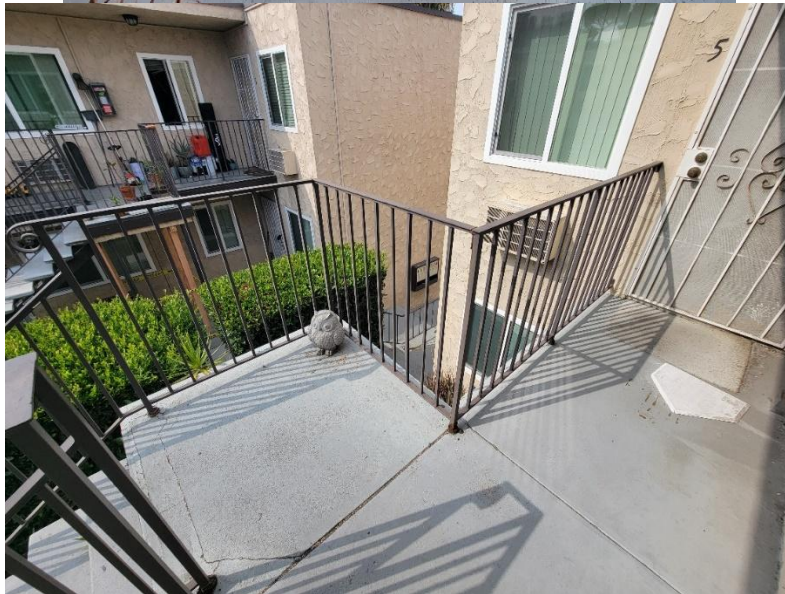
Picture 16: View of landing railing which is wobbly and unsafe

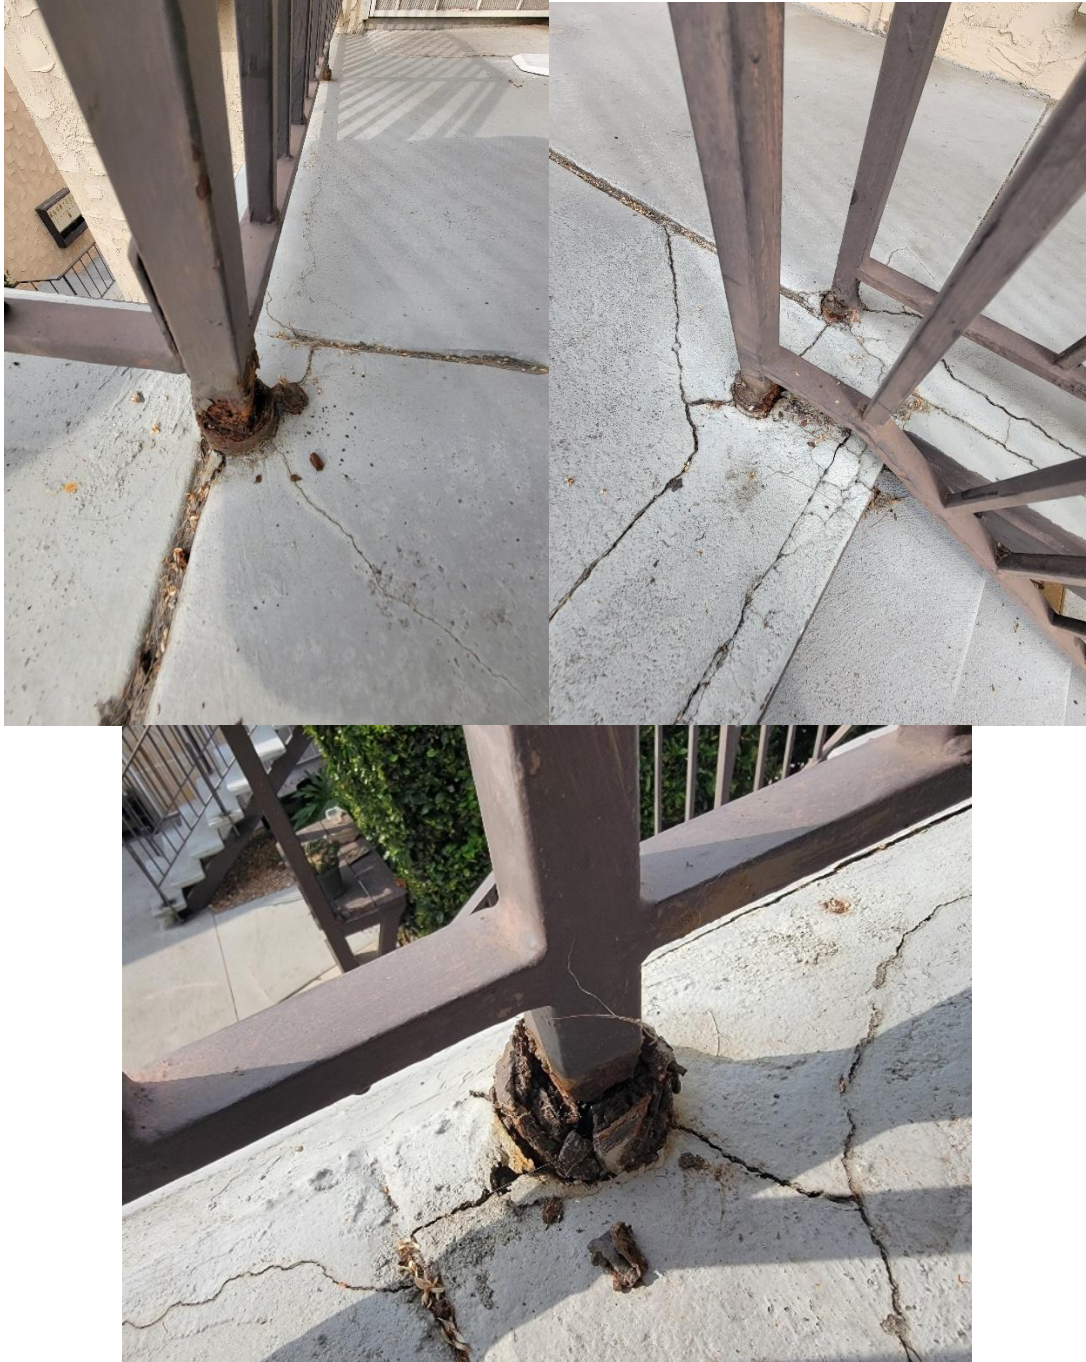
Picture 17: View of landing railing posts anchorage showing corroded post base post and anchorage to the cracked concrete topping which the railing is wobbly and unsafe

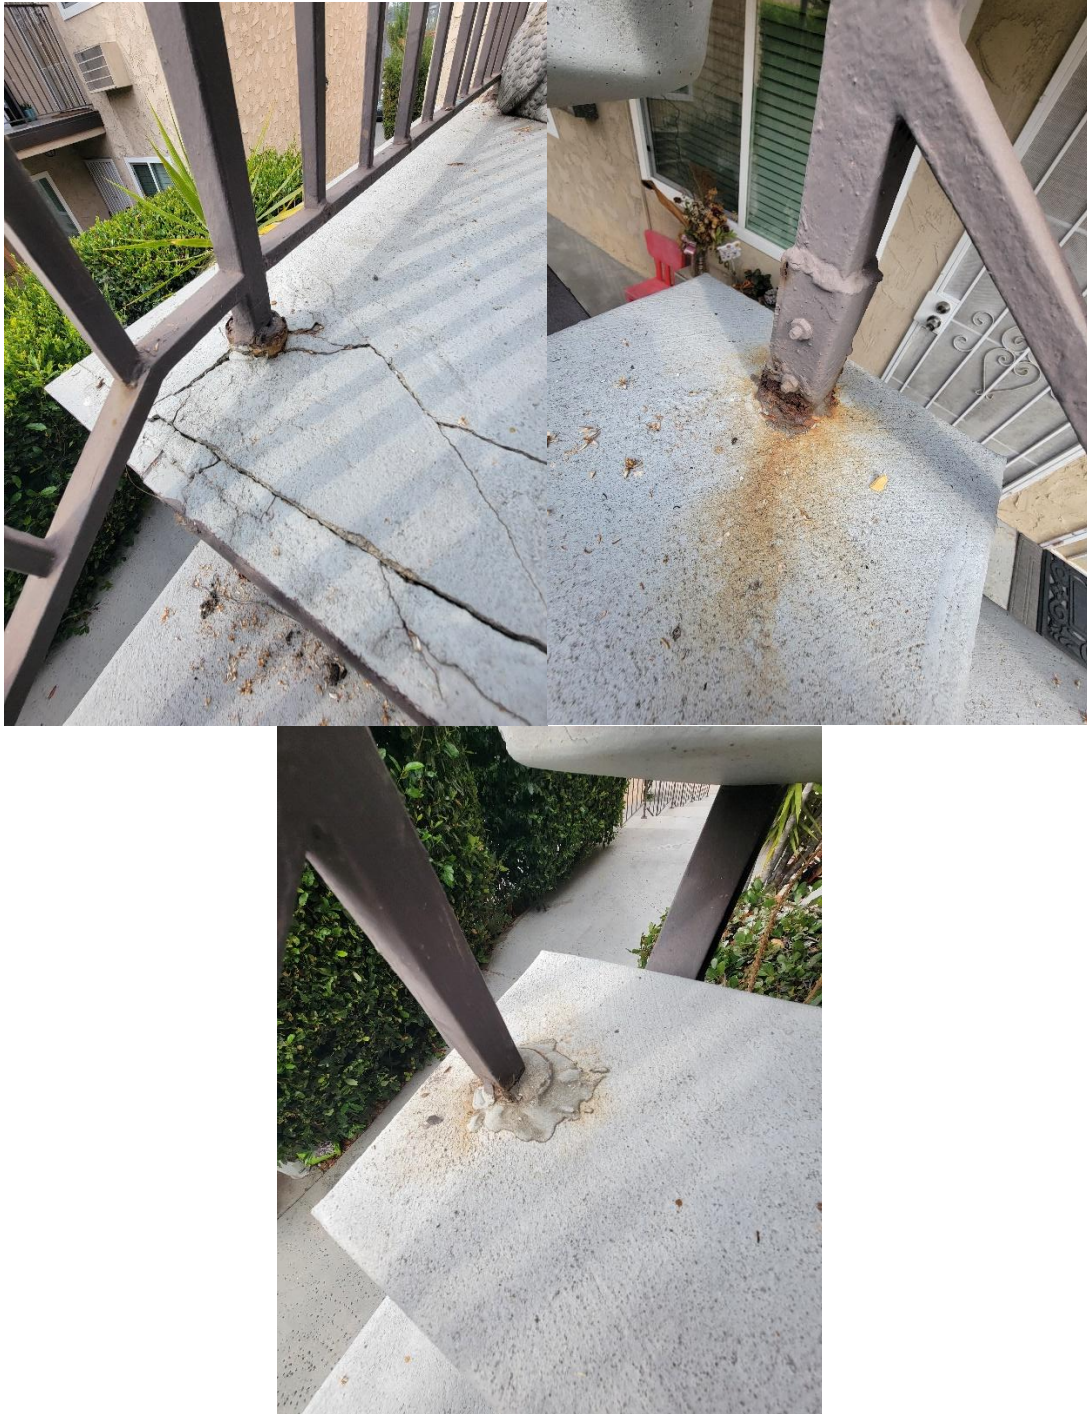
Picture 18: View of stair and landing railing posts anchorage showing corroded post base post and anchorage to the cracked concrete topping which the railing is wobbly and unsafe

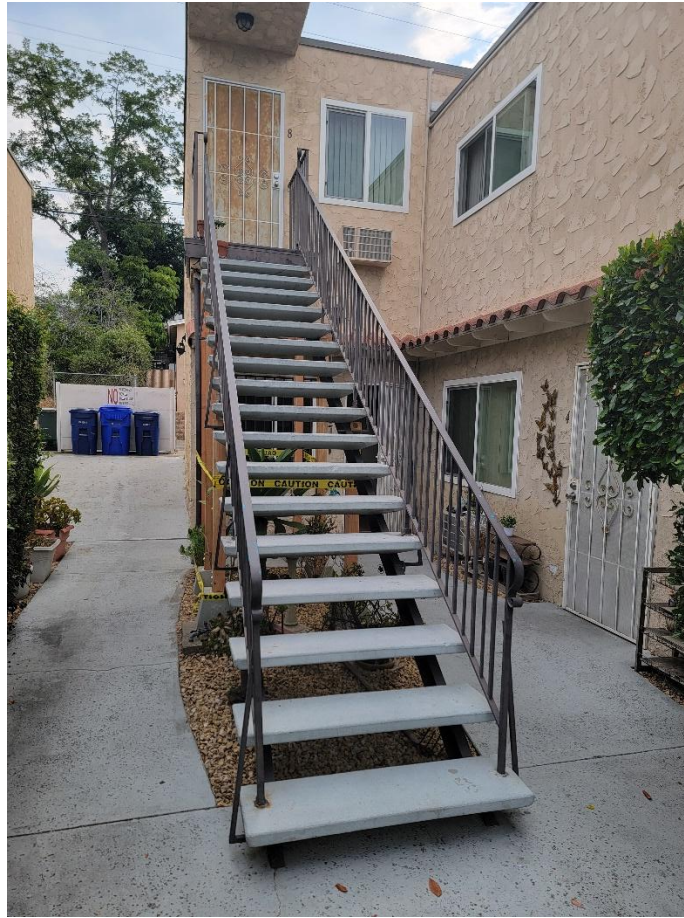
- 2- On the north stair at 4653 3<sup>rd</sup> street, the west stair railing is wobbly and unsafe. Different types of non-standard stair railing post anchorage to the concrete treads and railing landing to cracked concrete topping have been observed. (Refer to Pictures 19, 22, and 23).

Picture 19: North stair at 4653 3<sup>rd</sup> street which the left (west) stair railings is wobbly and unsafe.

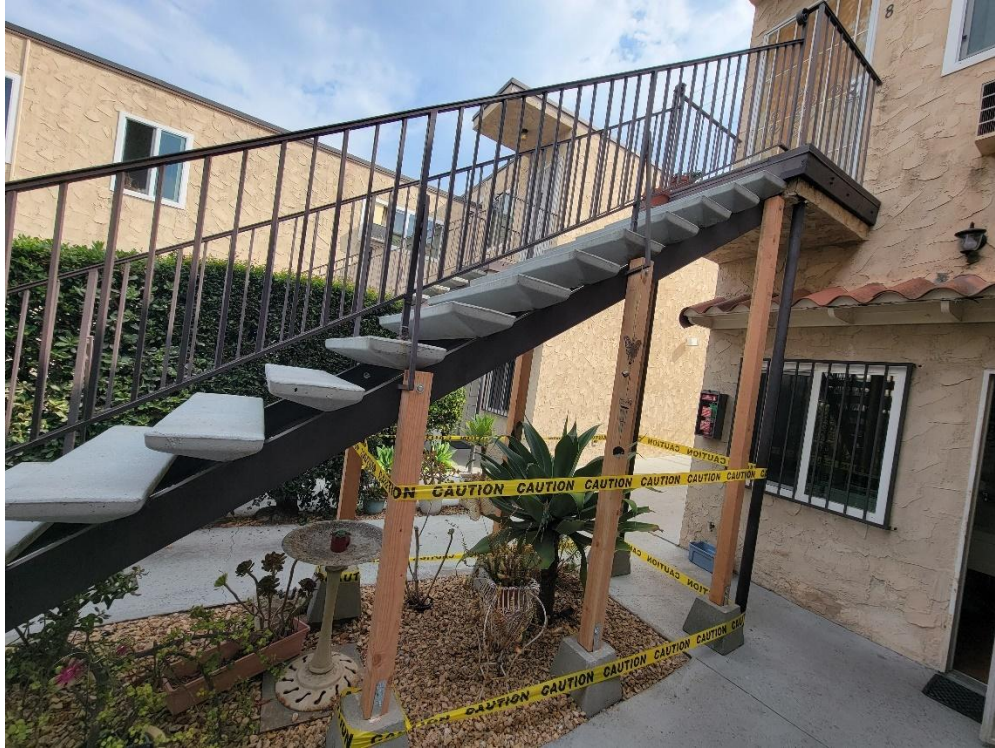
Picture 20: View of north stair at 4653 3<sup>rd</sup> street which has been temporarily shored.
