July 18, 2024

4653 & 4659 3<sup>rd</sup> street, La Mesa, CA 91941

Subject: Senate Bill #721 & 326- Structural Evaluation of existing exterior stairs at 4653 & 4659 3<sup>rd</sup> street, La Mesa, CA 91941

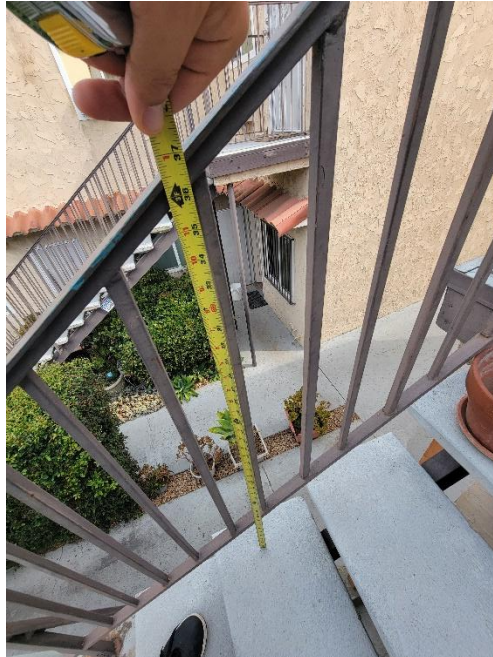
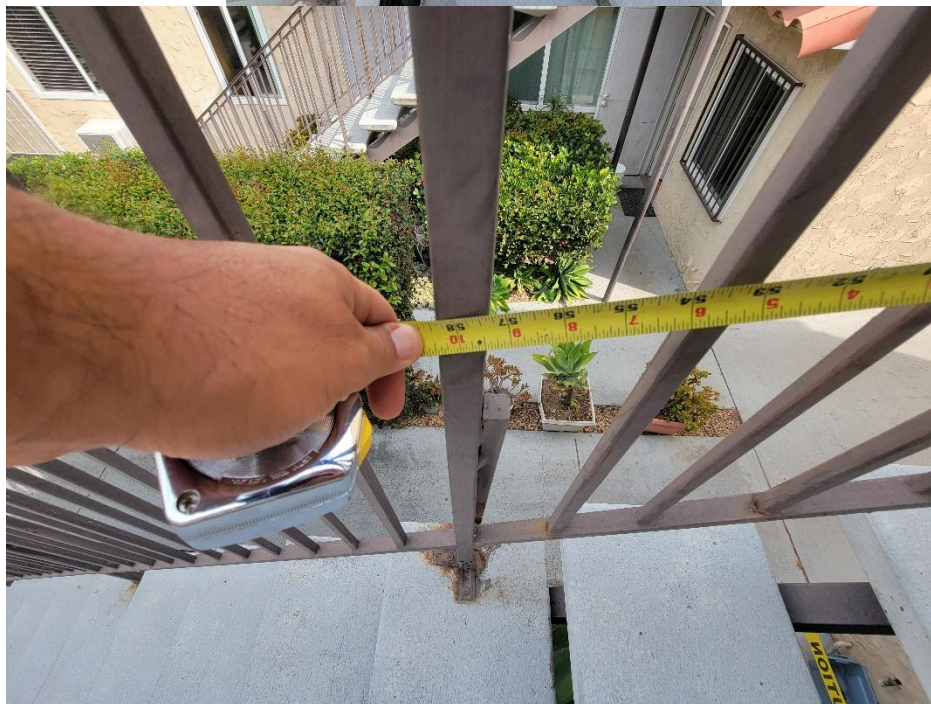
Picture 21: The stair railing is 36" high, post spacing varies with approximately 4 feet 10 inches post spacing on this picture.

To replace the proper guard railing system to comply with the current code, the existing stair and landing/walkway condition shall be verified by reviewing the record drawings when available or removing the topping concrete to measure the concrete thickness and locate the buried framing below and evaluating any possible hidden wood deterioration on joist/beams or corrosion on steel framing under the concrete topping. Note that removing, replacing, and repairing any possible dry rotted wood or corroded steel framing might be required. When the thickness of concrete topping is not adequate for future post anchorage, other methods of anchorage such as anchor to wood framing/ blocking or steel framing below should be investigated. When as-built information of framing is available, the new railing configuration and anchorage design comply with current codes that should be conducted and designed by a professional engineer.

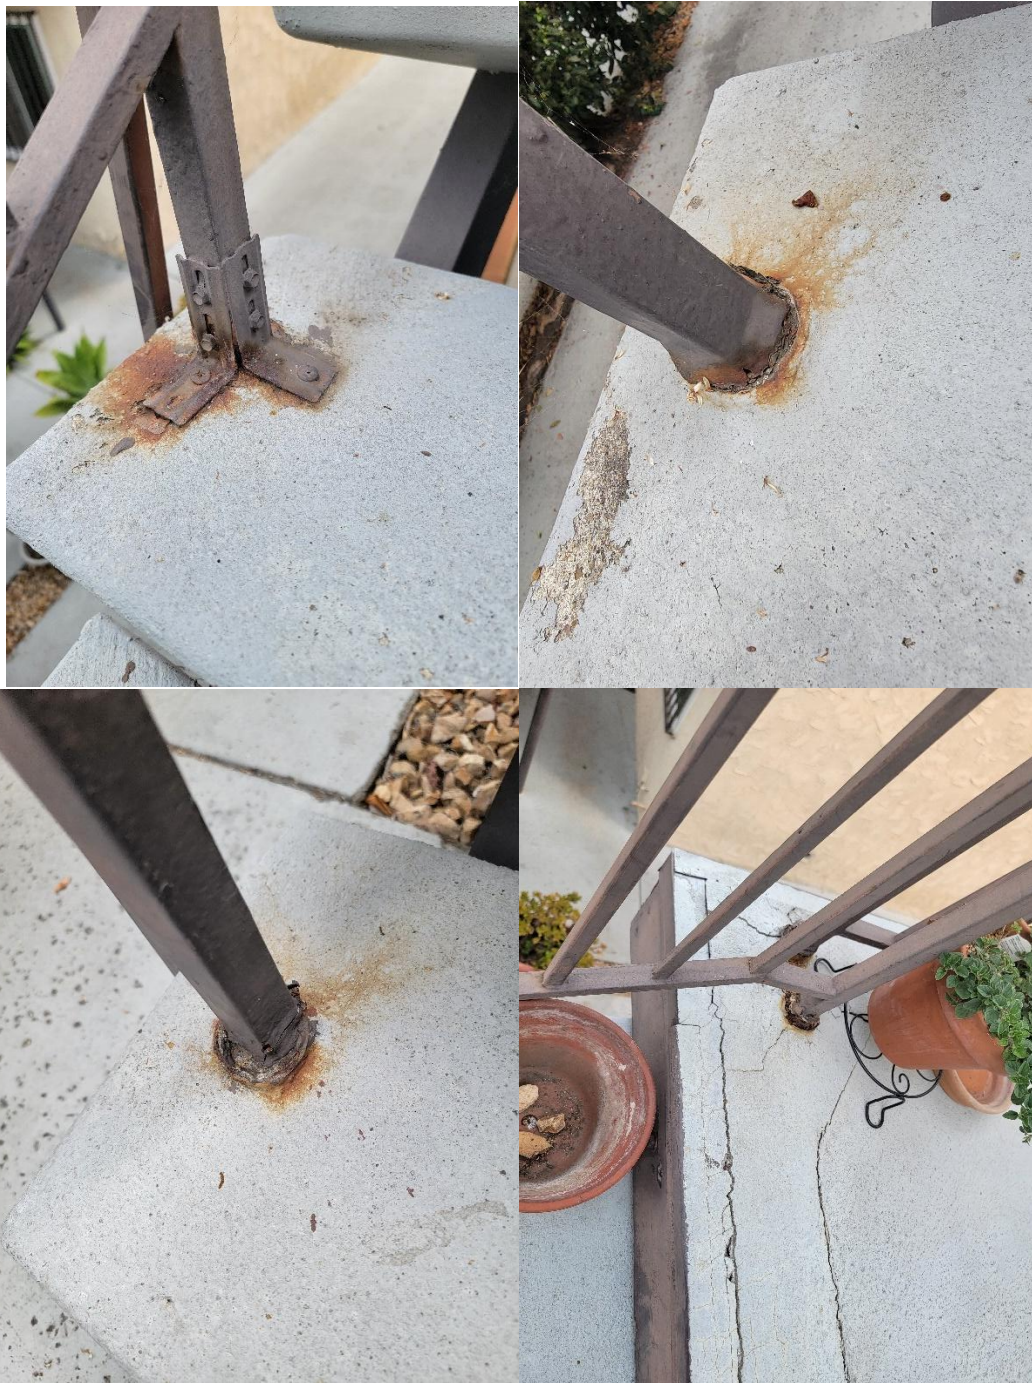
- 2- On the north stair at 4653 3<sup>rd</sup> street, the west stair railing is wobbly and unsafe. Different types of non-standard stair railing post anchorage to the concrete treads and railing landing to cracked concrete topping have been observed. (Refer to Pictures 19, 22, and 23).

Picture 22: Different non-standard stair railing post anchorage to the concrete treads and railing landing to cracked concrete topping.

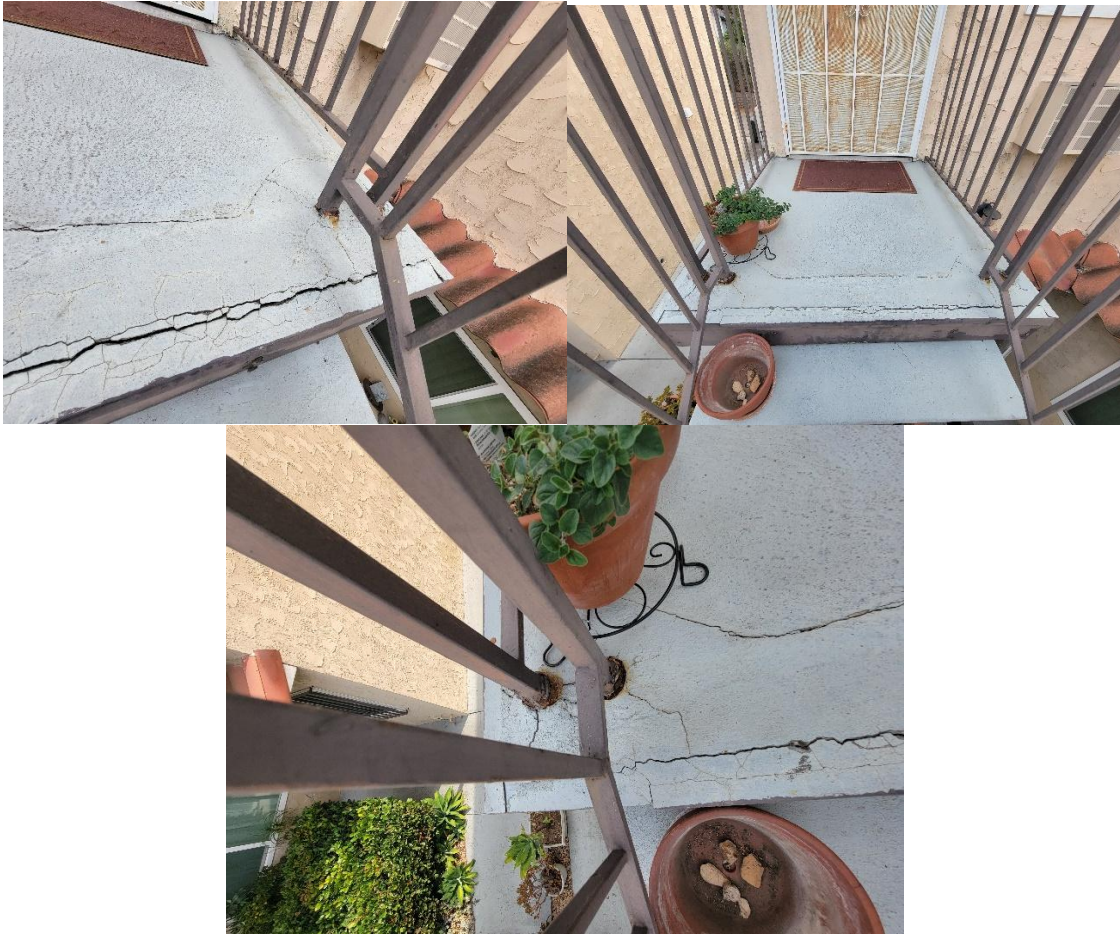
Picture 23: Different non-standard railing post anchorage to the landing's cracked concrete topping.

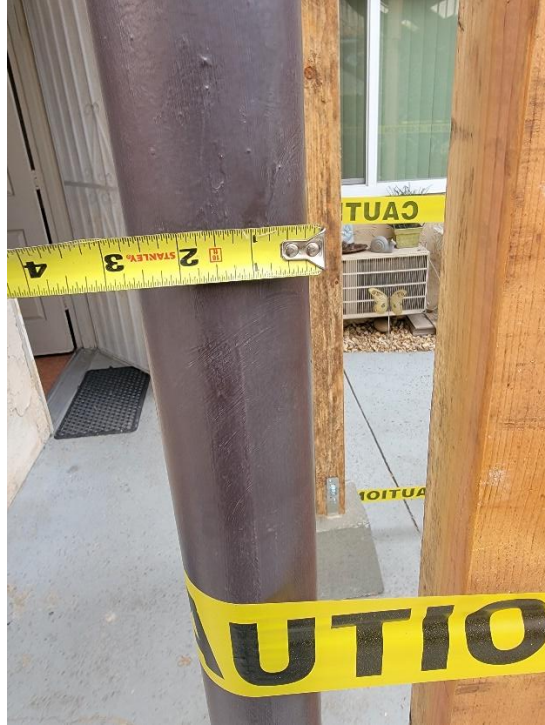
Picture 24: Typical steel tube post measured 3" outer diameter.

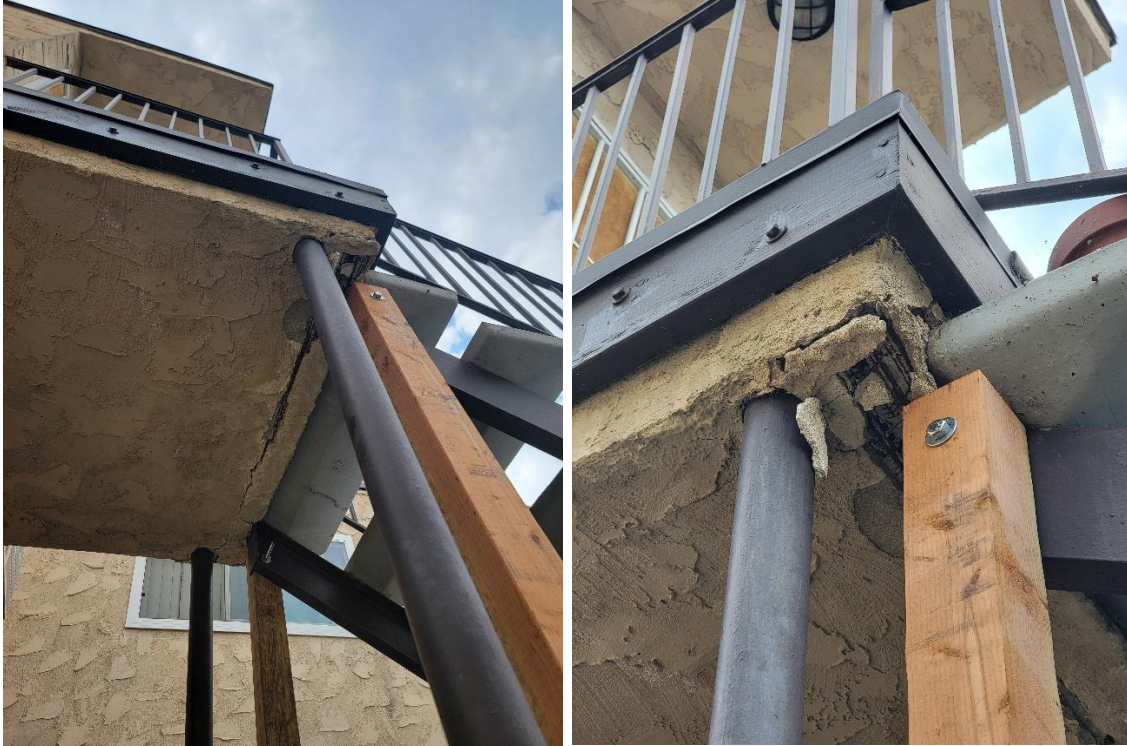
- 2- All of stair steel stringer connection to the landing structure are questionable as the stucco near the connections are cracked. The connections required to be exposed for further evaluation. Especially on the south stair at 4653 3<sup>rd</sup> street, the stair is settled on the west side approximately 1" relative to the east side of it. (see pictures 7, 16, 25, 30, and 32).

Picture 25: View of stair steel stringer connection to the landing's framing which is not exposed to be verified. Temporary shoring has been constructed. Cracked stucco along the stair connection observed.

All of stair steel stringer connection to the landing structure required to be exposed for further evaluation.

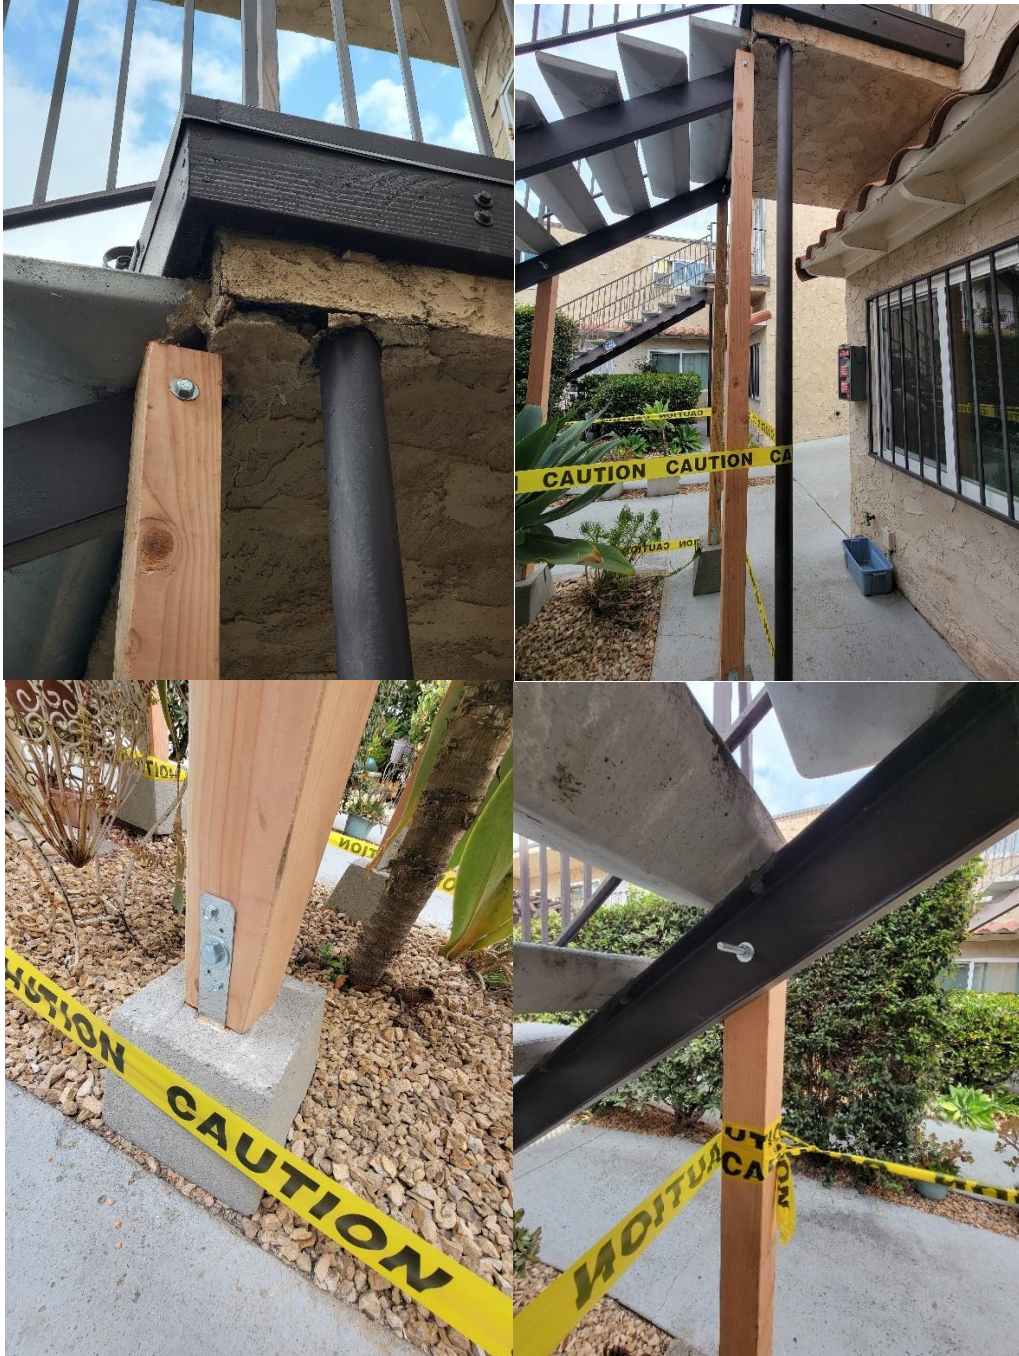
Picture 26: View of temporary shoring including 4x4 posts, block footing, bolted connection to the steel stringers.

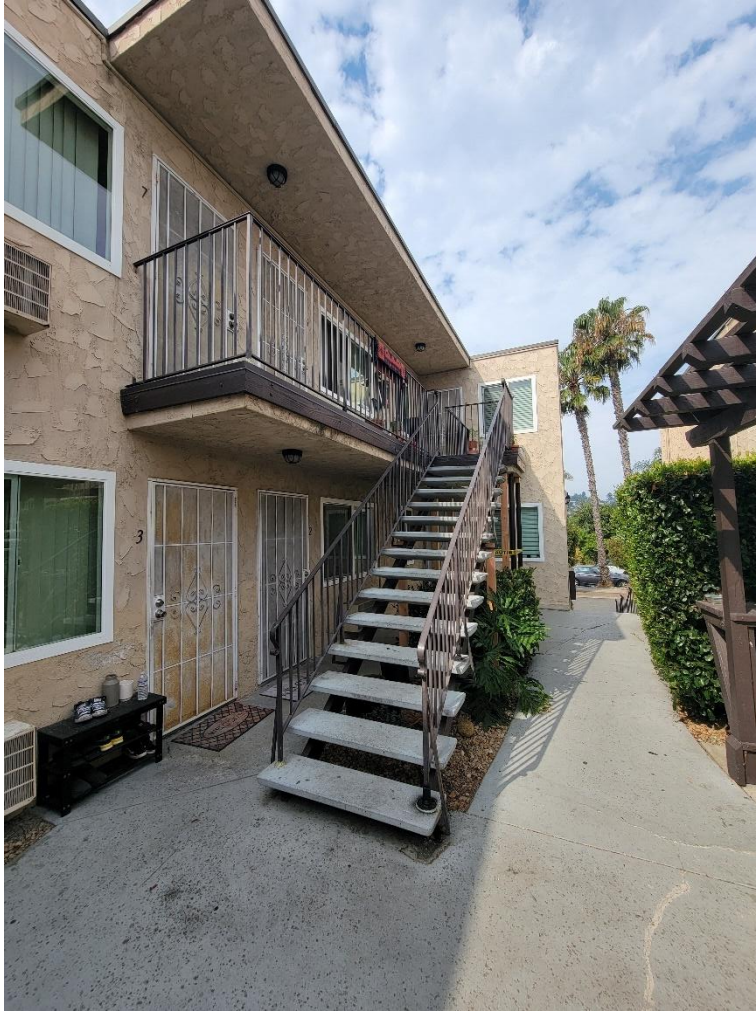
- 3- On the south stair at 4653 3<sup>rd</sup> street, the west stair railing is wobbly and unsafe. Different types of non-standard stair railing post anchorage to the concrete treads have been observed. (Refer to Pictures 27 and 28).

Picture 27: South stair at 4653 3<sup>rd</sup> street which the right (west) stair railings is wobbly and unsafe.

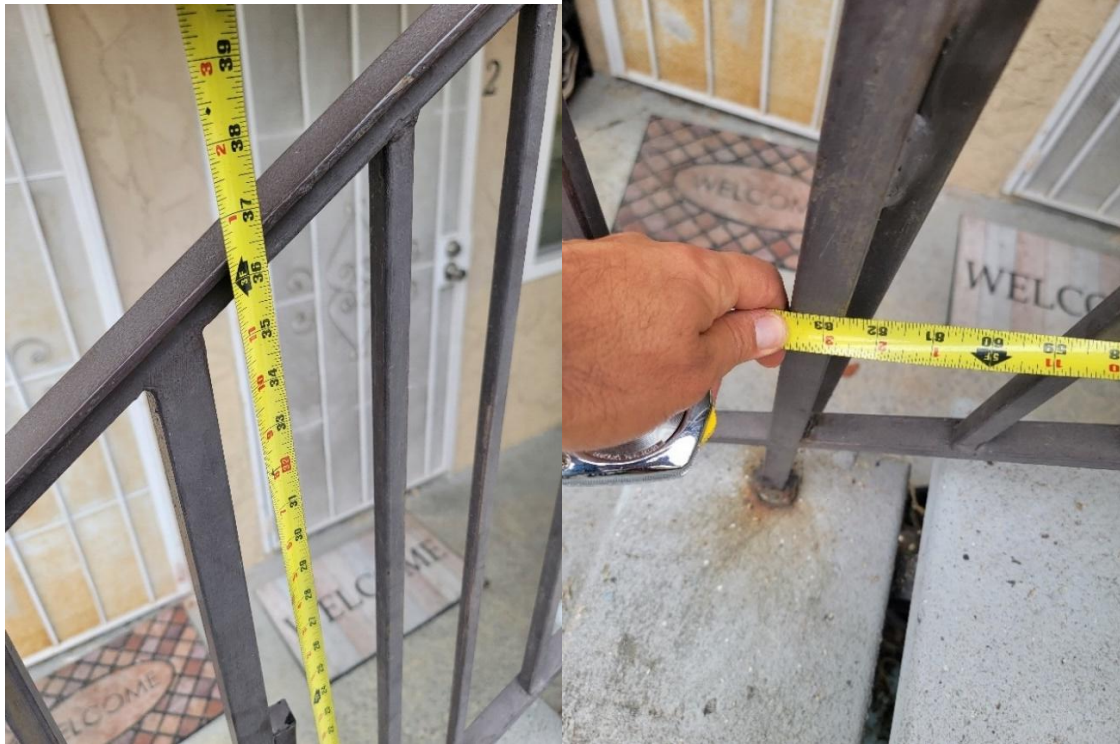
Picture 28: The stair railing is 36" high, post spacing varies with approximately 5 feet 3 inches post spacing on this picture.

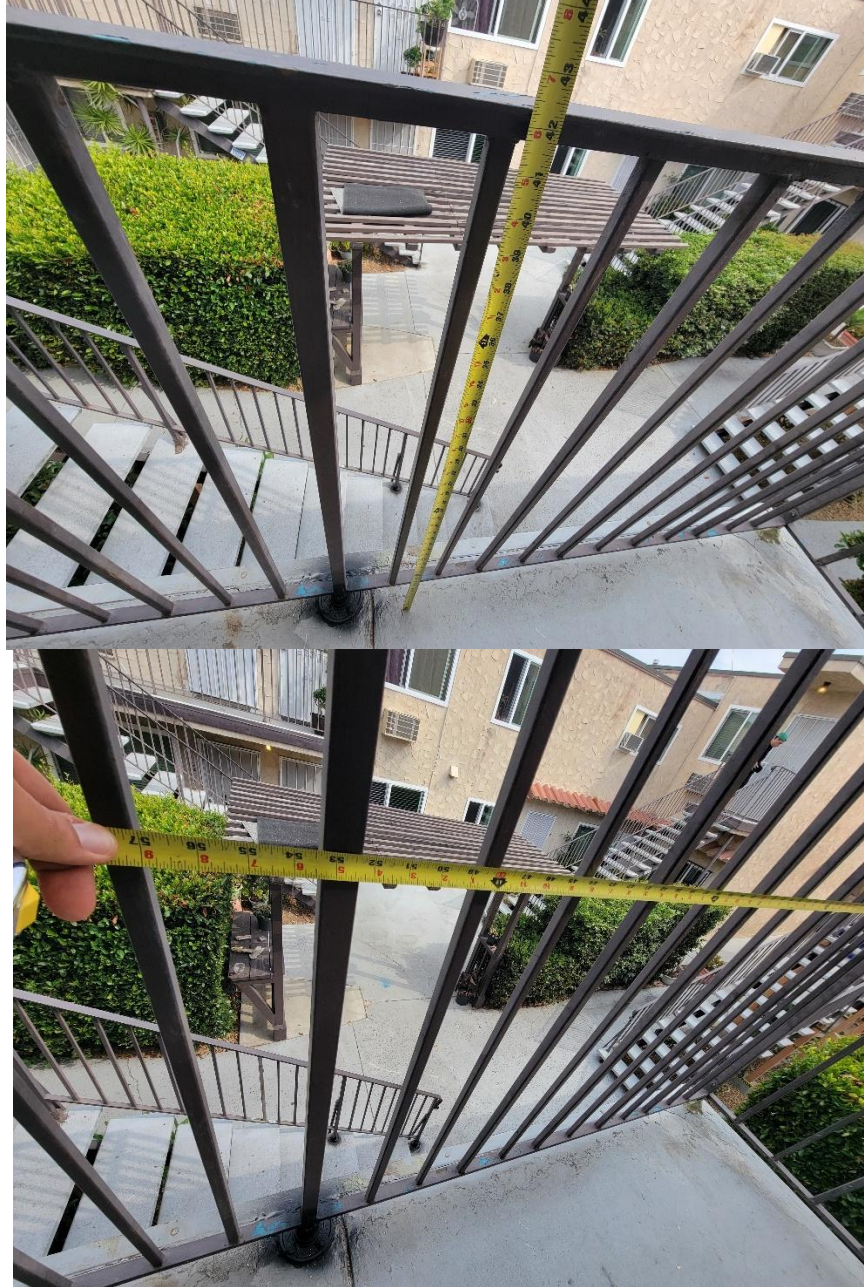
Picture 29: The landing railing is 42" high, post spacing varies with approximately 4 feet 5 inches post spacing on this picture.

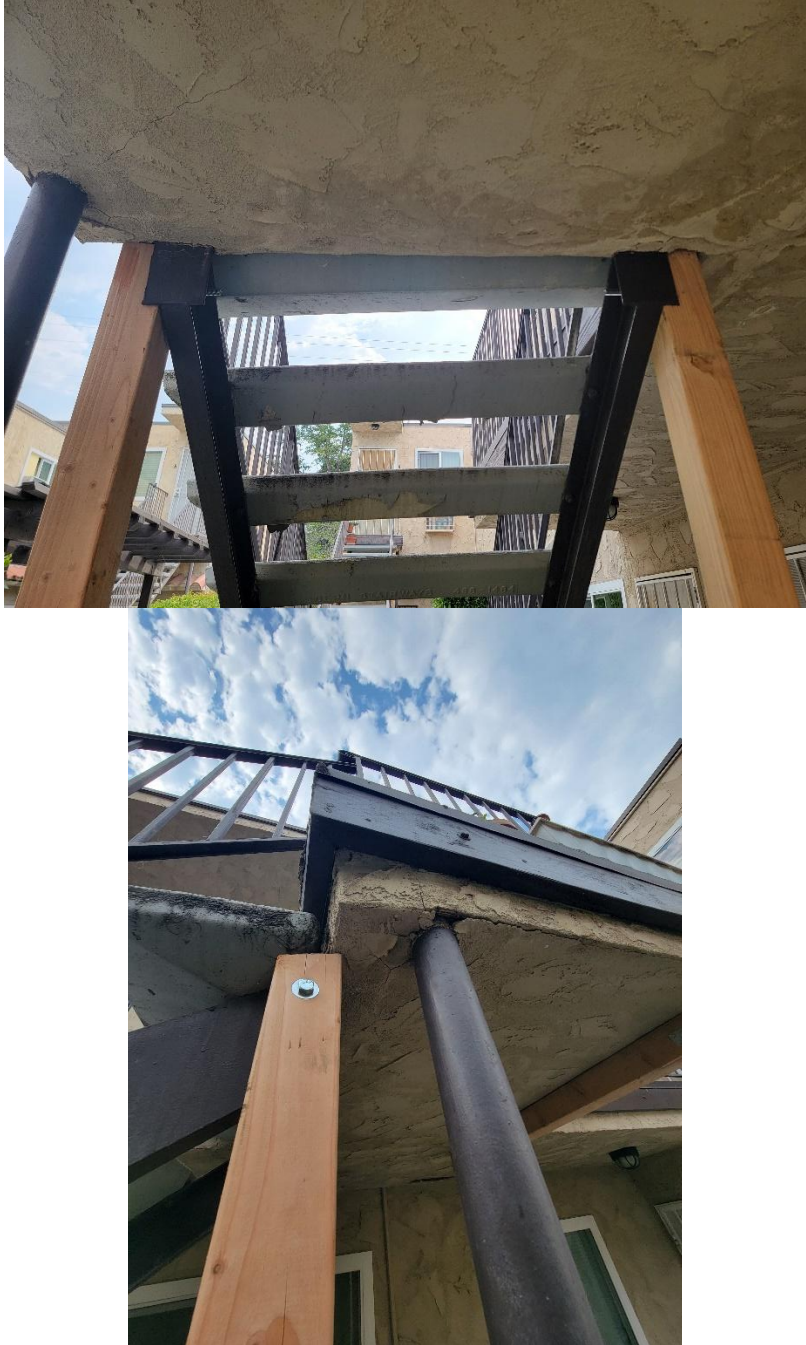
Picture 30: View of stair steel stringer connection to the landing's framing which is not exposed to be verified. Temporary shoring has been constructed. Cracked stucco along the stair connection observed.

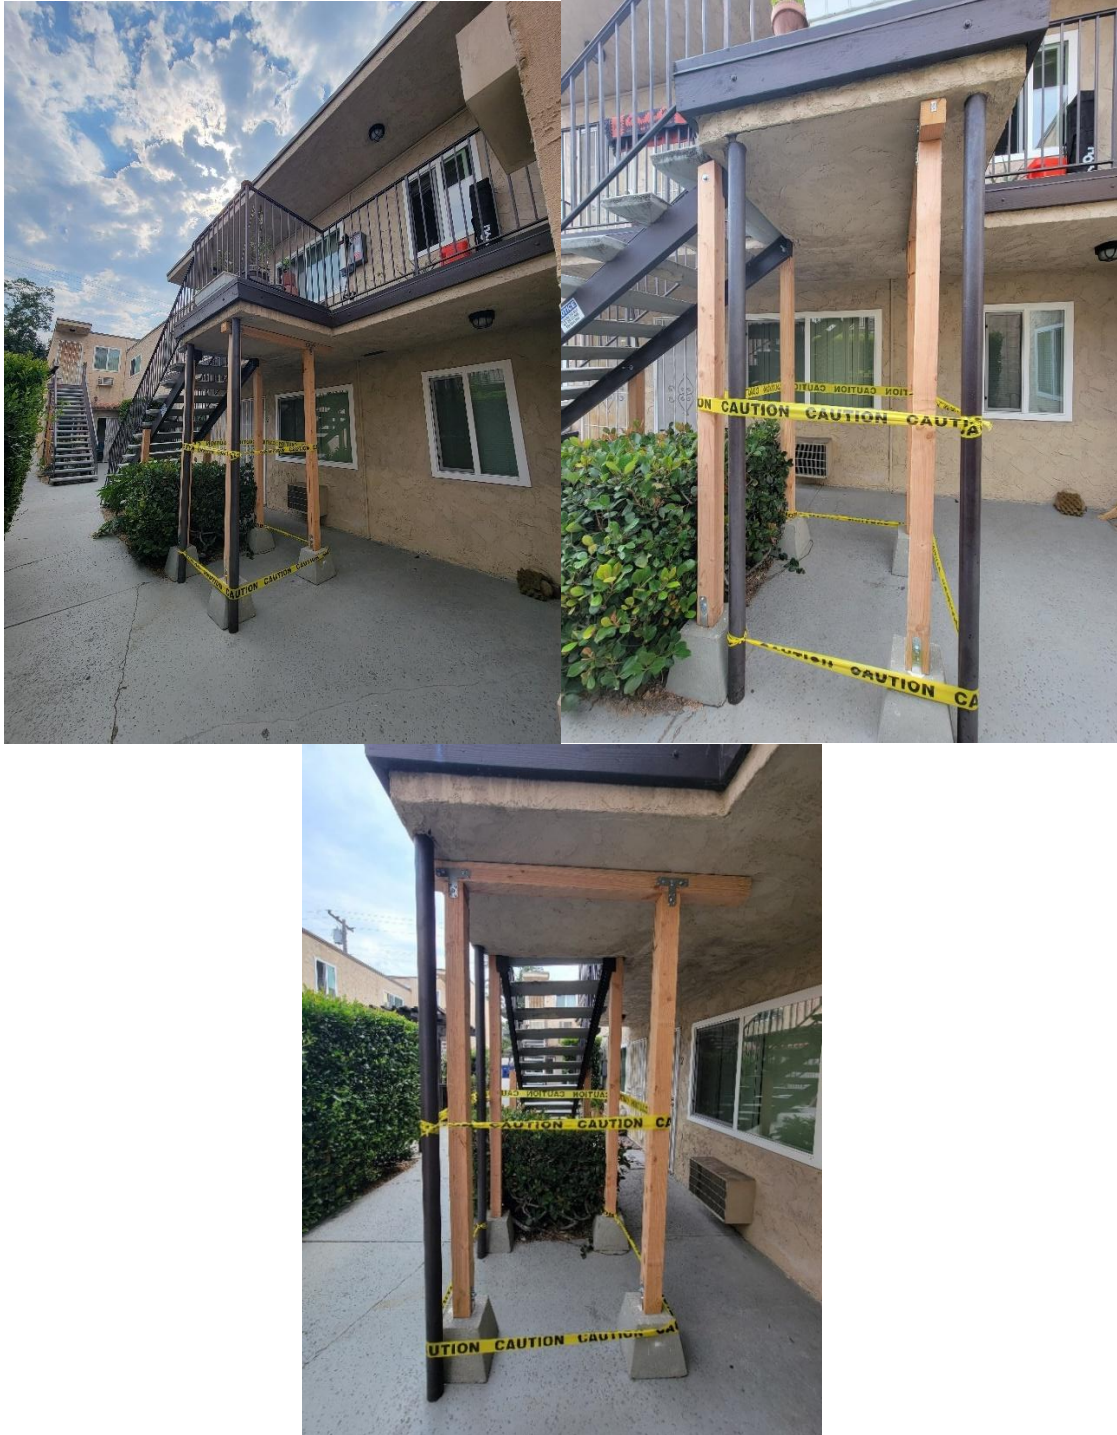
Picture 31: View of temporary shoring including 4x4 beam and posts, and concrete block footing.

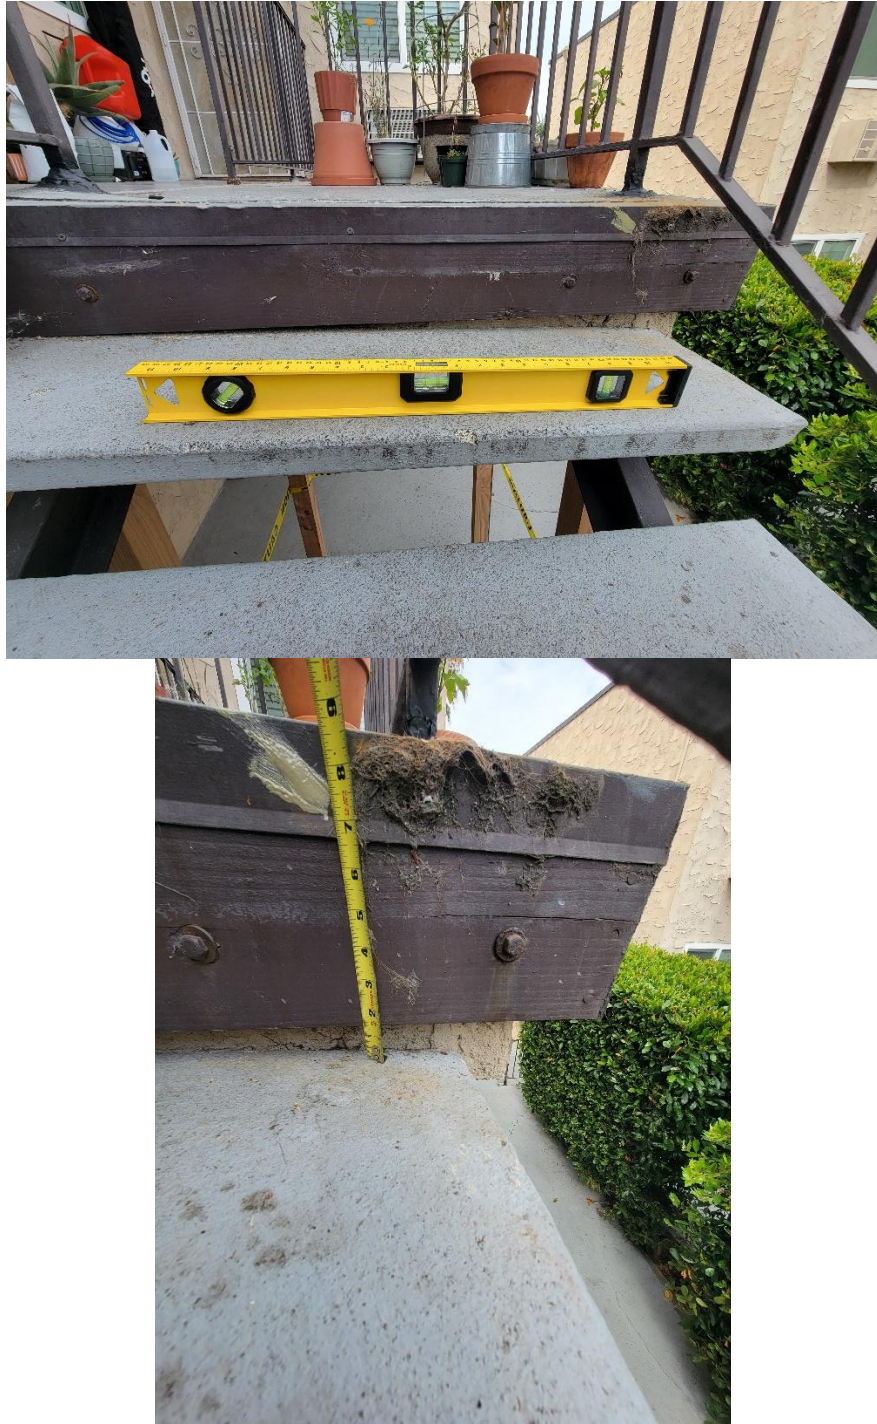
Picture 32: Stair is settled on the west side approximately 1"

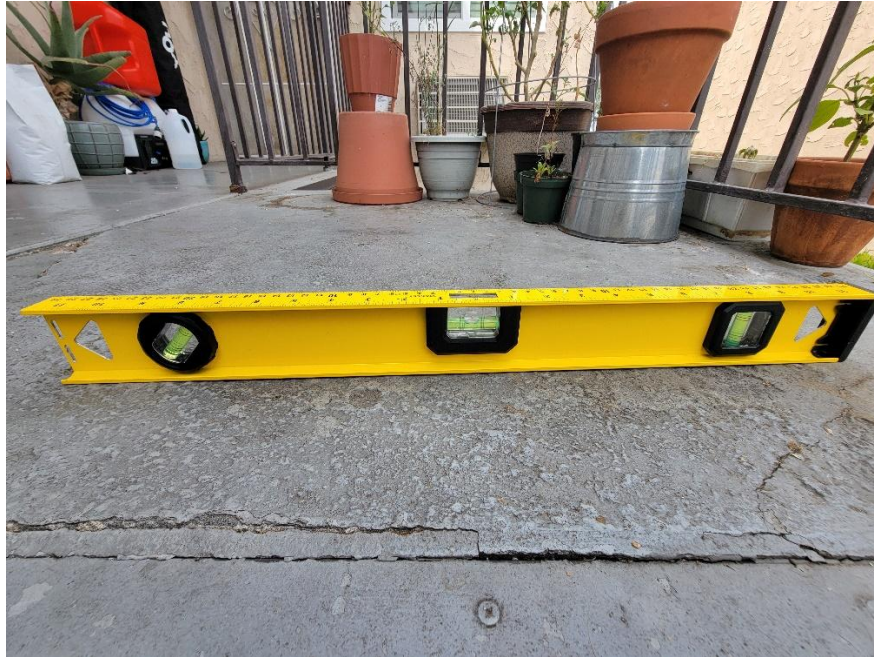
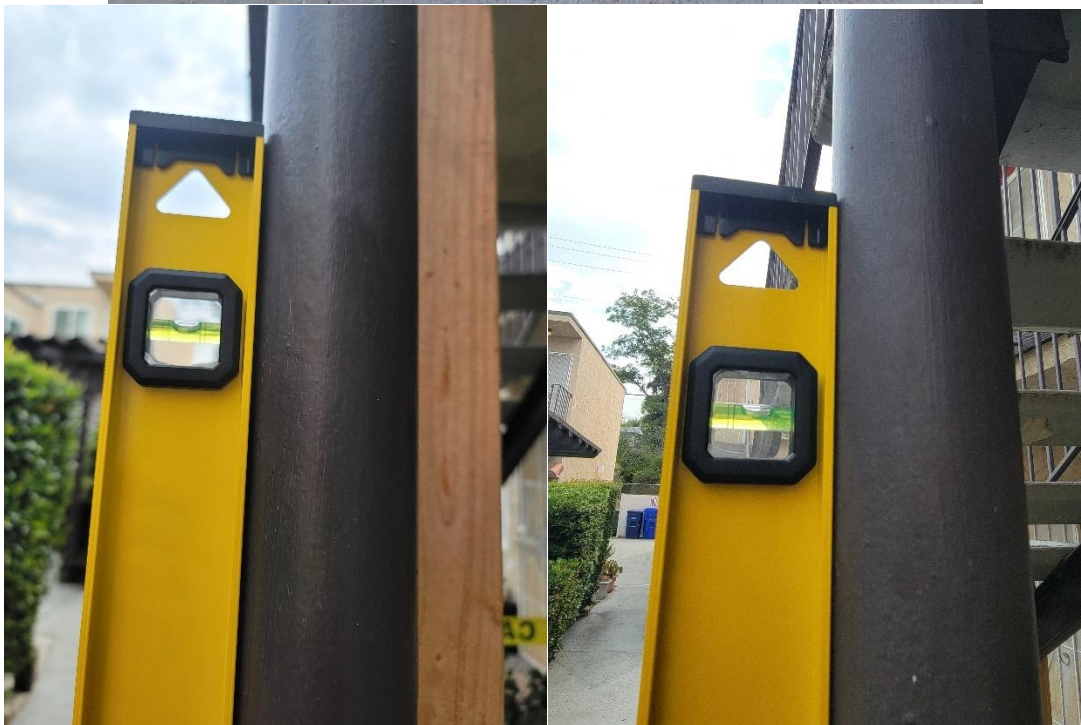
Picture 33: Landing is level, and the posts are vertically aligned “plumb”

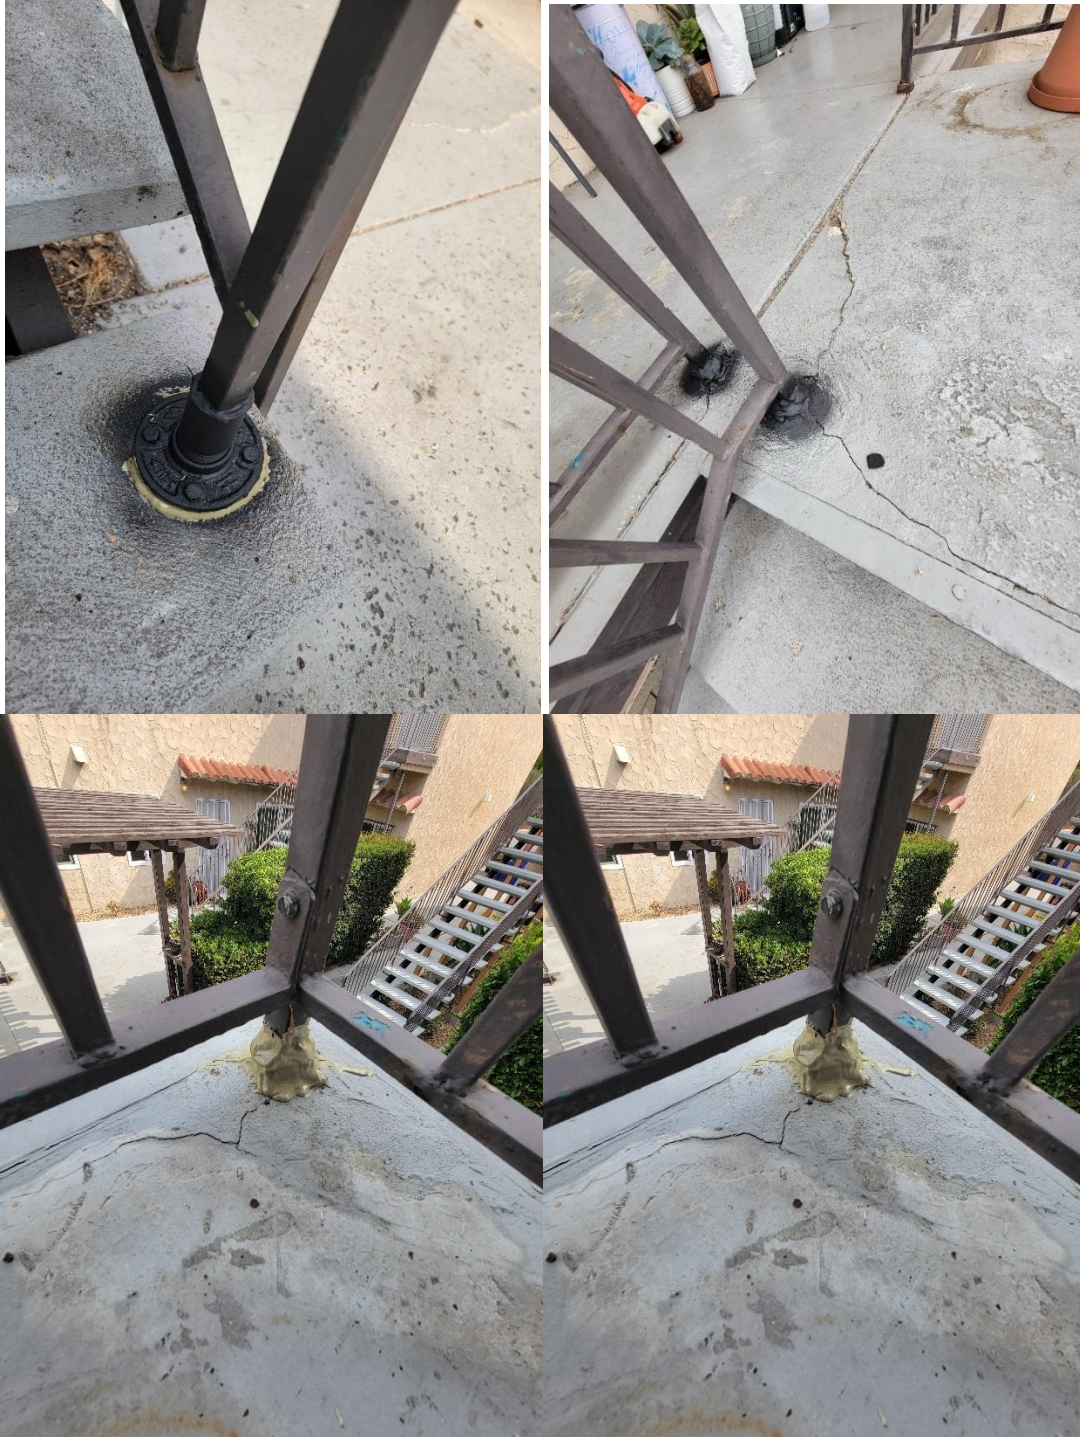
Picture 35: Different non-standard railing post anchorage to the landing's cracked concrete topping.

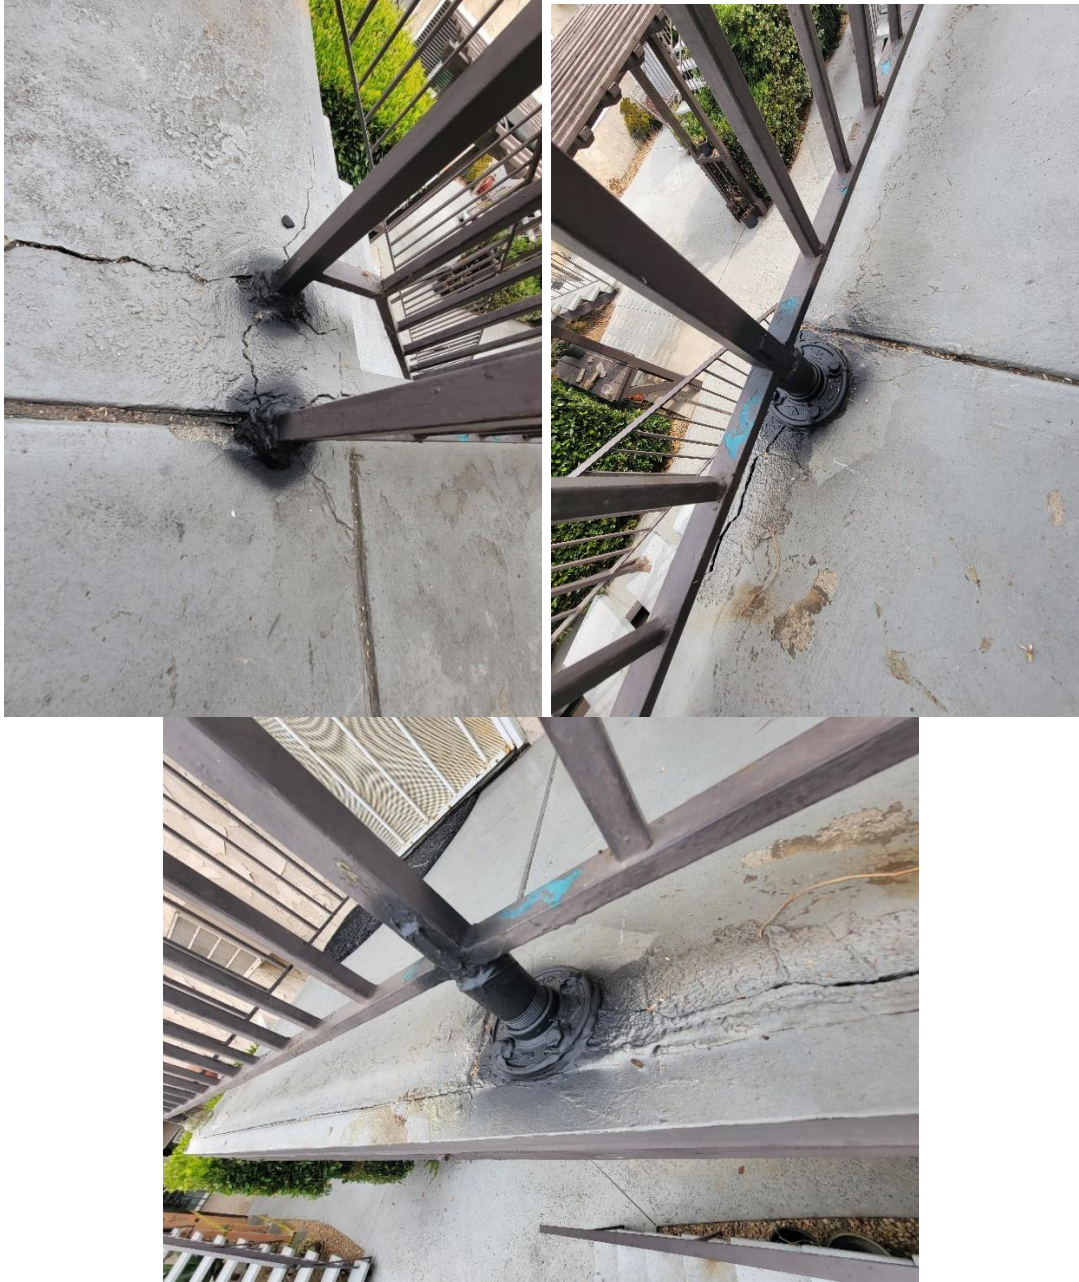
Picture 36: Different non-standard railing post anchorage to the landing's cracked concrete topping.

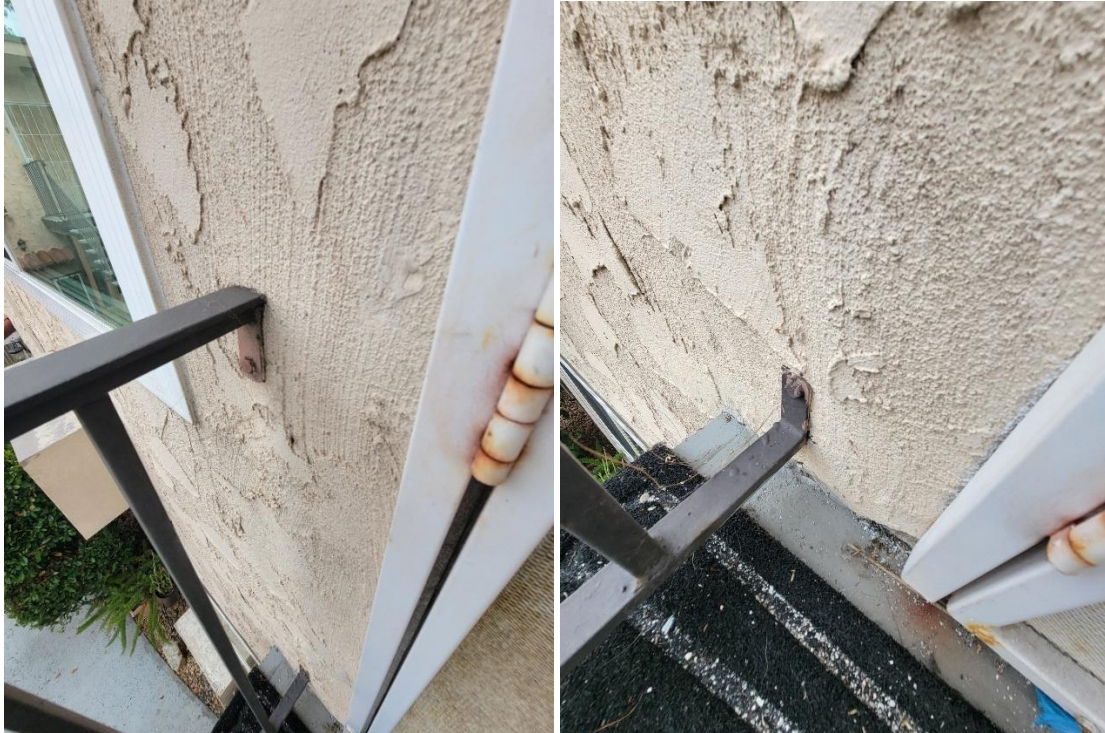
Picture 37: View of the landing railing anchorage to exterior stucco wall
